## THE PROBLEM WITH THE ZINC COATING DIVERSIFICATION OF THE HOT-DIP GALVANIZED STEEL

Sylwia WĘGRZYNKIEWICZ<sup>1</sup>

1- BELOS-PLP S.A., 43-300 Bielsko- Biała, gen. J. Kuźnia 74, e-mail address:

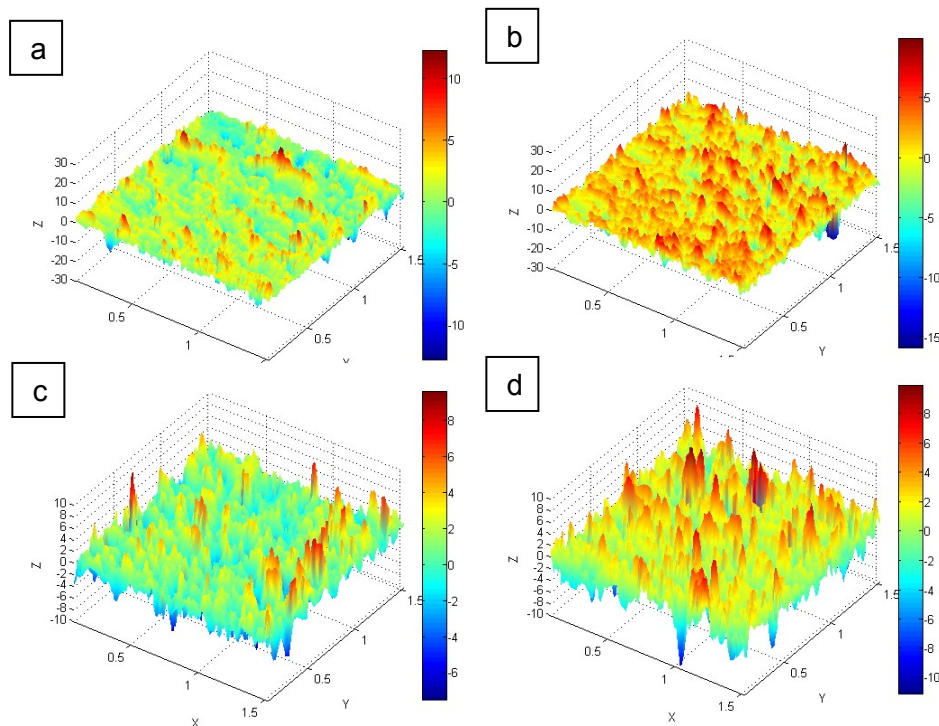
**Fig. 2** Surface topography of links: a,b - the flat surface (after rolling), c,d - the side surface (after cutting); a, c - before shot-blasting, b, d - after shot-blasting

Roughness parameters	The flat surface of link (crude- after rolling)		The side surface of link (after OAB cutting)	
	Before shot-blasting	After shot-blasting	Before shot-blasting	After shot-blasting
Ra [ $\mu\text{m}$ ]	1,42	2,44	5,31	5,72
Rv [ $\mu\text{m}$ ]	10,38	14,66	16,20	11,12
Rp [ $\mu\text{m}$ ]	9,85	9,84	14,59	9,88

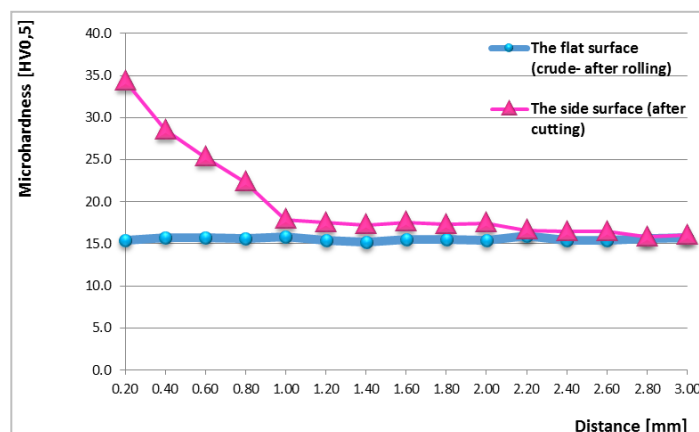
In the first stage the hardness (HV10) of flat and side surface was measured. The measurement was conducted perpendicularly to cutting plan. The average values from a dozen places of the measurement were as follows: on the flat surface - **155 HV10**, on the side surface - **356 HV10**.

**Fig. 3** Results of hardness measurement (HV0,5) on the flat and side surfaces of link in direction from cutting edge to the sample core

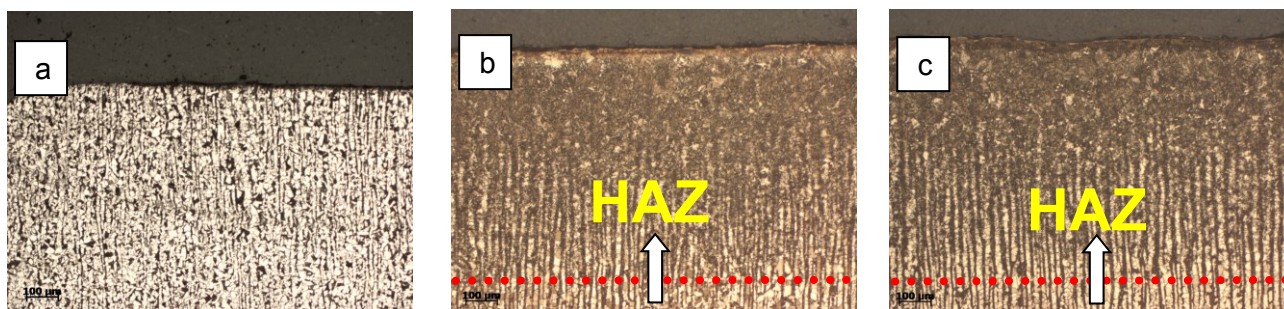
**Fig. 4** The S355JR steel structure: a - the flat surface (rolled), b - the side surface (after OAB cutting) , c - the side surface (after OAB cutting) and shot-blasting

The structure of the material in the initial state was a little bit anisotropic, mainly ferritic with small amount of perlite. Figure 4 a presents a dark perlite area and a light ferrite area. In the observed HAZ zone the needle shape structure appeared - lower bainite, martensite (Fig. 4 b, c) created as a result of undesirable quenching treatment caused by cutting. The HAZ area boundary is running parallel to cut edge. Its width in the analyzed area amounts to about 800  $\mu\text{m}$ . After OAB cutting it is necessary to use mechanical treatment -

shot-blasting in order to remove scale, which has an influence on the surface roughness. In this case, a layer of about 30  $\mu\text{m}$  scale (Fig. 5) was removed. Roughness observed on the examined surface resulted from the steel shot used during the treatment before galvanizing. The more stress steel surface after shot-blasting than after OAB cutting is presented in Figure 4 c.

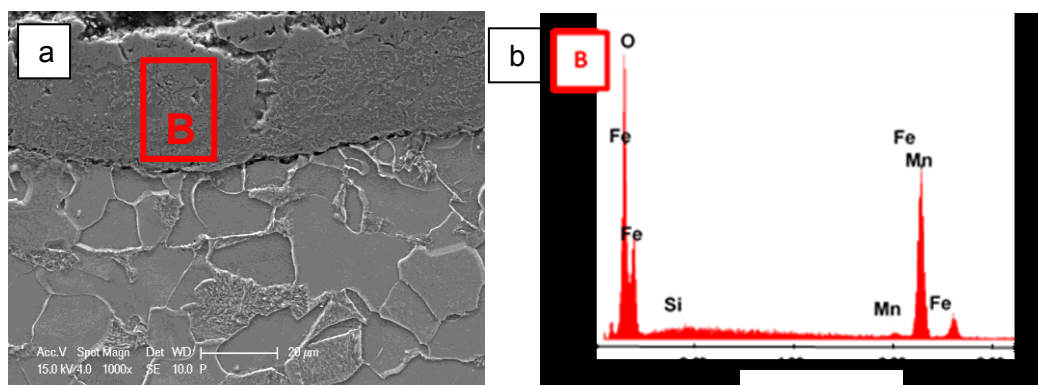
In order to fully identify the particular phases occurring in the surface layer after OAB cutting, an examination by scanning microscope PHILIPS XL30 with X-ray analyzer was conducted. The cross section of the steel structure observed after OAB cutting before shot-blasting and hot dip zinc galvanizing is shown in Figure 5 a, together with typical EDS graph of the oxides layer generated by thermal impact (Fig. 5 b).

**Fig. 5** The analysis of selected micro area in the surface layer after OAB cutting: a - the place of examination, b - EDS graph in micro area B

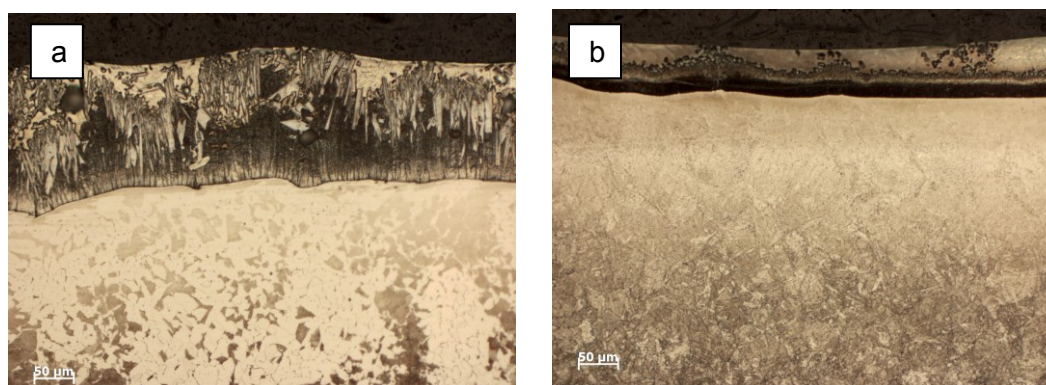
Metallographic examination were made for link after hot dip galvanizing and also confirms the diversification of zinc coating thickness and its structure. The measurement of Zn coating thickness was made for all samples after galvanizing. The average values from a dozen places of the measurement on flat and side surfaces are **158 µm** ( Fig. 6 a) and **59 µm** (Fig. 6 b).

**Fig. 6** The zinc coating structure: a - on the flat surface of link, b - on the side link surfaces of link

It has been observed that the abrasive blasting method - shot-blasting which was carried out in order to clean the surface before hot dip galvanizing is insufficient for a surface after OAB cutting. Zn coating thickness diversification on the flat surface and side surface is unacceptable. Shot-blasting may probably eliminate the lack of coating adhesiveness to the substrate. In this study no problems with this phenomenon occurred.

The zinc coating structure diversification. The Zn coating put on the flat surface (after rolling) reveals typical structure for this grade of steel - composed of phases:  $\Gamma$ ,  $\delta$ ,  $\zeta$  and  $\eta$  (Zn) (Fig. 6 a). Layers created by iron diffusion ( $\delta+\zeta$ ) occupy the greater part of the coating thickness (135 $\mu\text{m}$  - 84% of total thickness). The coating growth was not disturbed/hindered by the heat affection results of cutting (there is no HAZ) and the application of shot-blasting before galvanizing additionally supported proper process course. In case of Zn coating created on the side surface (after OAB cutting) the observed structure is quite different: the alloyed area is much thinner (40 $\mu\text{m}$  - 57% of total thickness) - the rest is occupied by pure zinc.

- using different cutting methods (laser and water-jet cutting)- thanks to that eliminating OAB cutting from the production of difficult fittings or
- using an additional treatment after OAB cutting for example normalizing annealing or grinding.

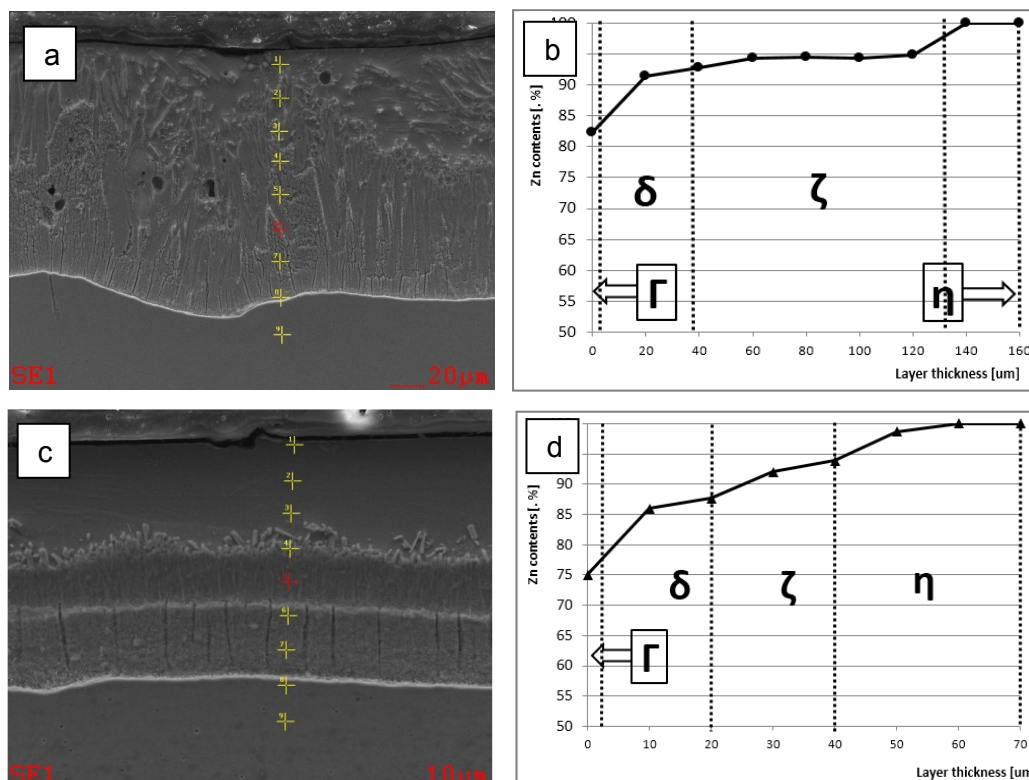
The cross section of the zinc coating structure on the flat surface of link is shown in Figure 7 a, together Zn distribution at the cross section of the coating (Fig. 7 b). The cross section of the zinc coating structure on the side surface of link is shown in Figure 7 c together Zn distribution at the cross section of the coating (Fig. 7 d).

**Fig. 6** The microstructure and Zn distribution at the cross section of the coating created on link: a, b - flat surface; c, d - side surface;
