## THE HAZARDS OF DEFECTS AND POOR QUALITY OF ALUMINIUM MATERIALS

Josef FORMÁNEK, Ludmila KUČEROVÁ, Mykhailo TOCHYLIN

University of West Bohemia in Pilsen, Univerzitní 22, 306 14 Pilsen, Czech Republic, EU, [skal@kmm.zcu.cz](mailto:skal@kmm.zcu.cz)

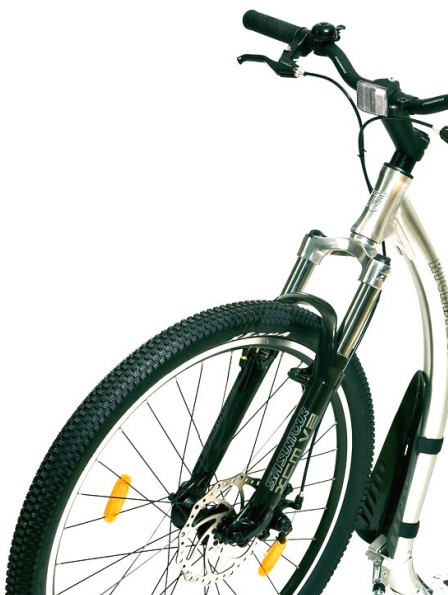
**Fig. 1** The front fork of a downhill sports scooter

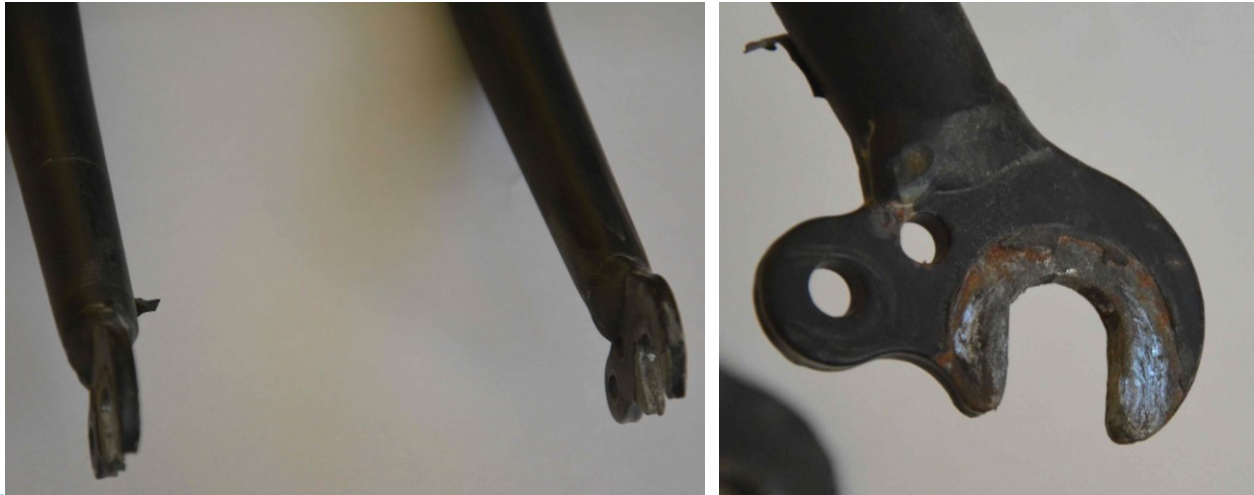
The loaded front wheel fork withstood test modes with only slight damage – enlargement of wheel mounts (see FIG. 2). The basic software simulation verified that the supporting profile was sufficiently structurally designed, and that is why no additional material analysis was carried out.

**Fig. 2** The steel front wheel mounts and detail of magnification opening handle

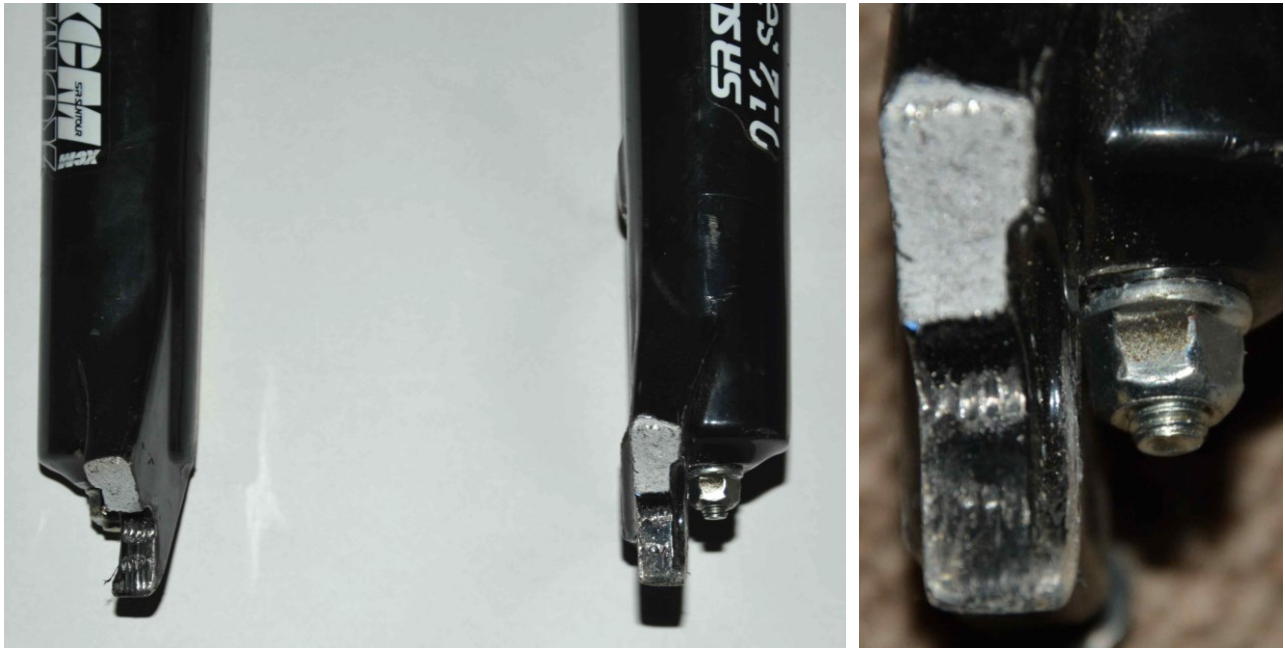
The front forks have a lifetime warranty, and subsequent control simulation using FEM verified that the front forks have a real long-term durability of several tens of years. The reality was however different, this part broke after about 700 km, the damage being at the front wheel mounts. Small initialization cracks were found upon closer examination (see **Fig. 3**). According to the basic simulation in the SW, it was verified that the carrier profile was sufficiently structurally designed to bear the load and therefore we proceeded to carry out material and fracture analysis. Metallographic sections were created and examined in detail with surprising results.

**Fig. 3** The damage to the front wheel mounts and detail of damage

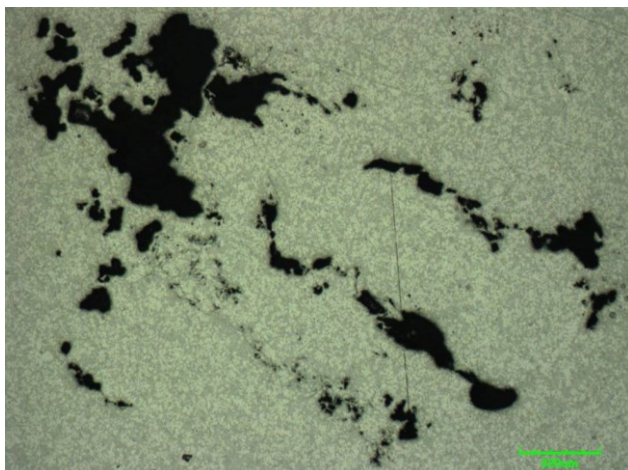
A metallographic sample was prepared from an area about 1cm below the fracture surface. Many pores and shrinkages of various sizes were observed at the polished surface of the sample, proving the poor quality of the material. These defects were so large that they were also visible by the naked eye, some of them reaching sizes in the range of mm (**Fig.3**).

**Fig. 3** Large shrinkage in material.

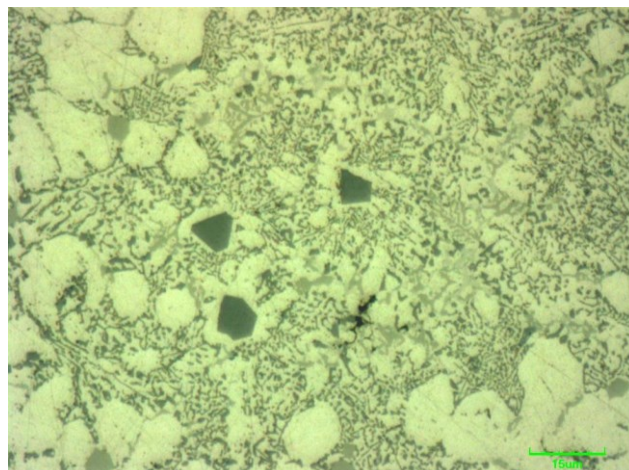
The sample was further etched using Keller reagent to reveal the microstructure. The microstructure was dendritic and rather complex, consisting of solid solution matrix with Al-Si eutectic among them (**Fig.4- Fig. 6**). A relatively large fraction of the microstructure, about 50%, consisted of primary aluminium  $\alpha$ -Al dendrites distributed relatively evenly in a eutectic matrix.

**Fig. 4** Dendritic microstructure with eutectic network and several kinds of particles.

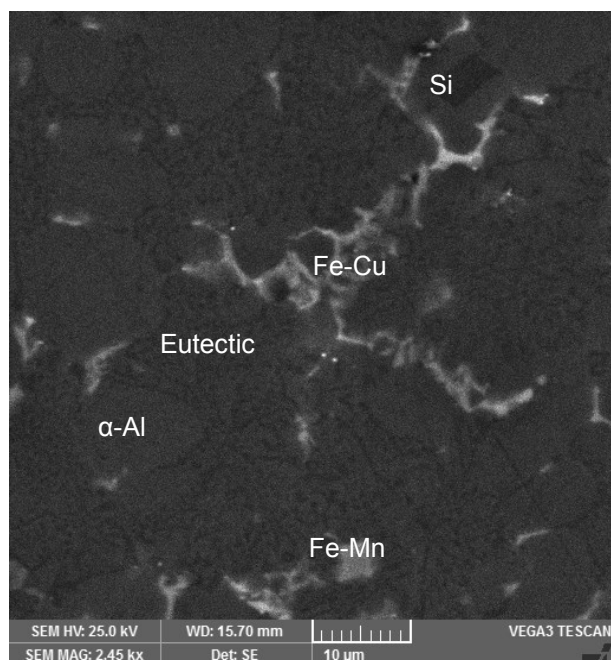
There was a network of fine particles with higher Cu and lower Fe content along dendrite boundaries, and two kinds of larger individual particles were found inside the  $\alpha$ -Al dendrites. Several dark sharp edged particles of primary Si were observed inside the dendritic areas and occasionally sharp edged light grey particles rich in Fe and Mn, with Fe:Mn ratio around 2:1 (**Fig.5-Fig.6**).

**Fig. 5** Dendritic microstructure of the fork with interdendritic eutectic network, particles at dendrite boundaries (Fe-Cu) and two kinds of larger particles inside dendritic areas (primary Si and Fe-Mn).

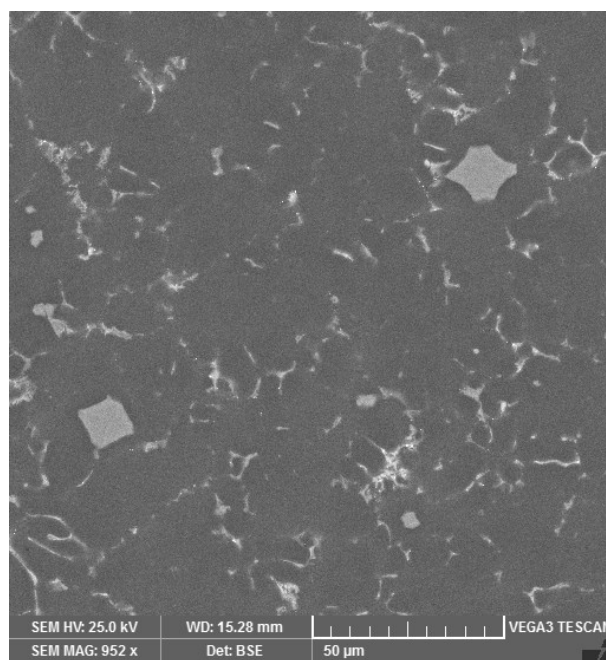
**Fig. 6** Detail of light iron-copper phase at dendrite boundaries and light iron-manganese sharp particles in BSE mode.

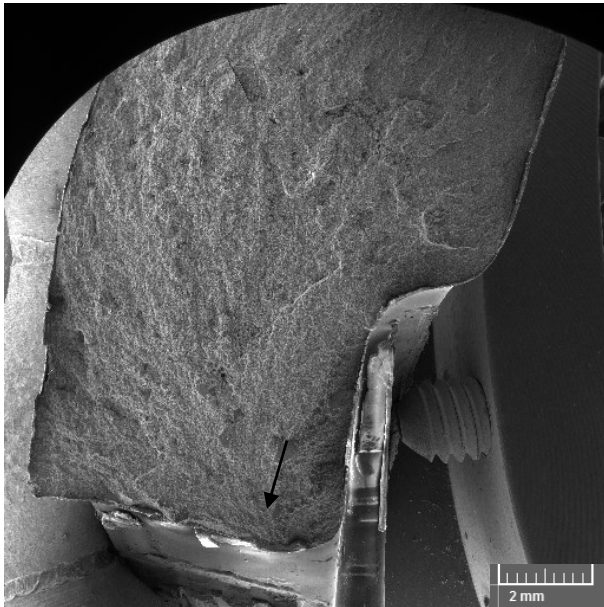
**Fig. 7** Fracture initiation area at the surface of the fork, larger shrinkages visible.

Both fracture surfaces were observed using a scanning electron microscope. The initiation of the fracture was just under the surface of the thinner part of the fork (**Fig.7**). The characteristic appearance of shrinkage casting dendrites is clearly evident and it is in agreement with the microstructure features (**Fig.8**). Brittle fracture areas, sometimes with oxidised surfaces, were observed in the shrinkages. The fracture surface between the shrinkage porosity exhibited a dimple rupture character. No evidence of progressive fatigue failure was observed anywhere on the fracture surface.

It can therefore be concluded that the dimple rupture fracture surface was the result of sudden impact, overload failure. Even though Al-Si alloy was a suitable type of material for this application and the addition of iron further improved its impact resistance and endurance limit, the presence of shrinkage and porosity resulted in significant decrease of the real cross section of the part, thus contributing to the overload of the remaining volume of material.

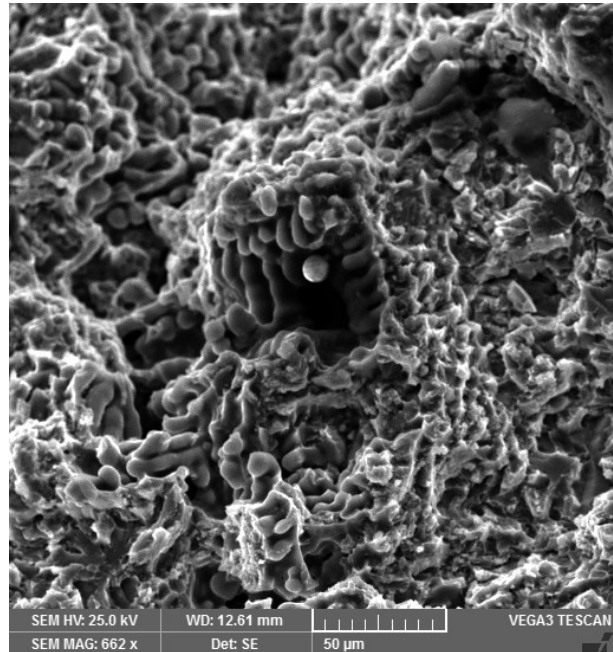
**Fig. 8** Dendrites on the fracture surface
