## **ANALYSIS OF THE DAMAGE OF FUNCTIONAL BASED ON THE COBALT-RESISTANT ABRASION LAYERS**

### **Abstract**

Cobalt-based alloys (e.g. Stellite) are often used on surfaces which are required for the high resistance to abrasion (sealing surfaces of the fittings, etc.). These surface layers are commonly applied to low alloyed steel Grade 22 or martensitic steel Grade 91 by welding techniques using. When using armatures with these layers in energetic plants (high pressure valves) have shown operating experience that occurs in damage to functional layers often. The typical damage is characterized by cracking and flaking (release) of the functional layer. This paper deals with the analysis of the causes of such damage to the surface layer of the ball valves (or their contact faces) after the low-cycle service application in superheated steam (550°C / 10MPa). Layers were applied to the steel AISI 316. For this research were used methods of metallography, chemical and SEM analysis, phase and XRDA microanalysis, hardness and microhardness testing. It was found selective cracking in the areas of a specific phase composition. The subsequently release of materials particles and other damage t

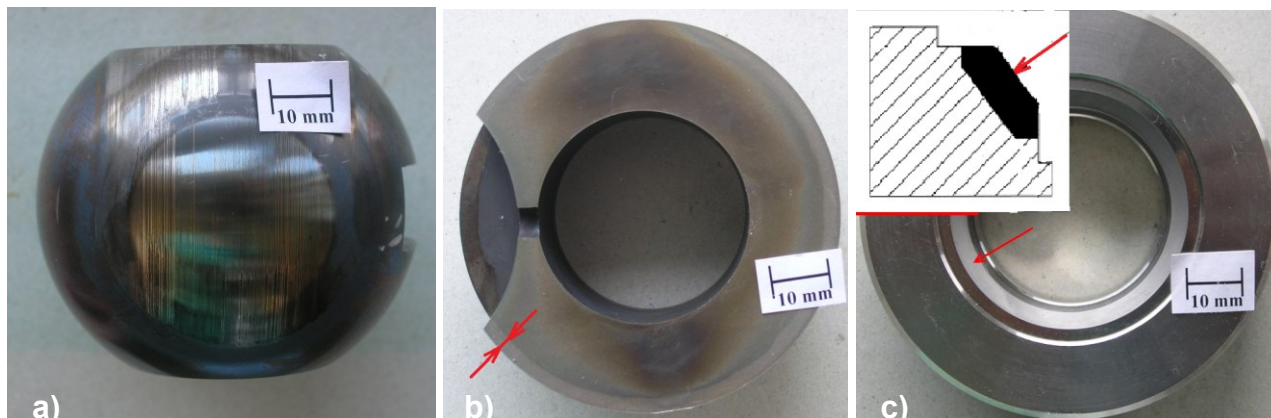
The problem for research was a significant damage to the surface of the ball of the ball valves, after a very short operational exposition – approx. 12 months at approx. 50 cycles of changes the position. After this time, there were signs of leakage of valves and these have been dismantled. The valves worked in an environment of superheated steam at temperature 550°C and pressure 10MPa. There were three balls (with marking A, B, C) with a diameter of 72 mm (A, B) and 112 mm (C) and one piece valve seat E (fig. 1). Basic material of balls was steel AISI 316, welding surface Stellite 6, at seat next P 91 vs. Stellite 721. Standardized chemical composition and hardness of both welded materials is in the table 1. [1, 3] Surfacing was realized by OFW technique. After the surfacing is done finish and lapping surface. The declared thickness of the weld layer was approx. 3 mm.

**Fig. 1** Ball valves; a) - ball B – outlet side; b) - cross section of ball A cutting by electro-erosion method; c) - valve seat; Stellite welding layers are marked with red arrows

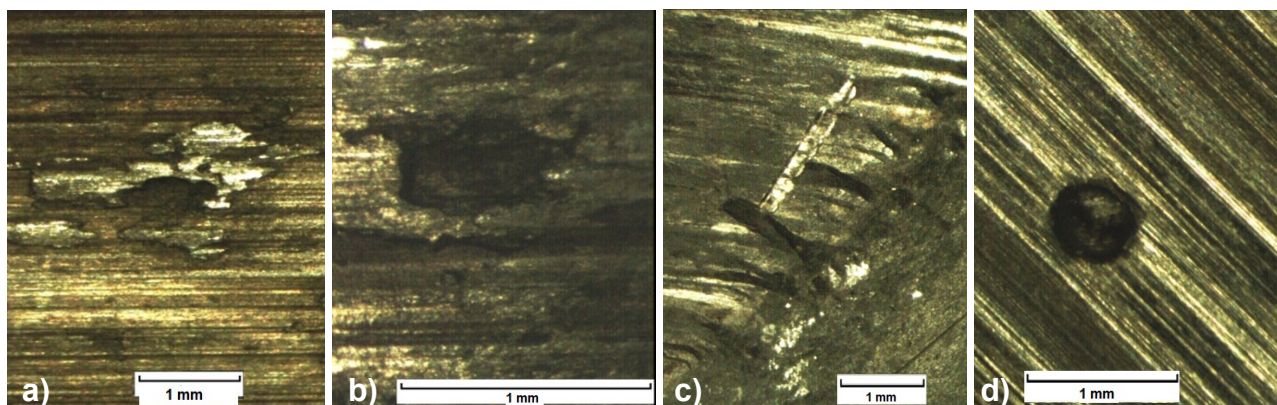
Due to the damage character has been done thorough documentation supplied parts of the ball valve with an emphasis on damaged areas by digital camera. These areas were also documented by optical stereomicroscope Olympus SZX12 at a magnification of up to 20 × whereas several types of damage were found, including posts that suggest that their rise was by separation (peeling) of upper part of welding layer (fig. 2a, 3a), including probably initiation points. Most was the damage caused by erosion of the free particles (fig. 2d), which is significant by grooves rise. In addition, were detected marks of foreign material adhesion on the ball surface also (fig. 2b, 3b). In places the damage of lapped sealing surfaces were found to have marks of damage by flowing steam and erosion attack (fig. 2c), that could be the cause of the detectable leakage of the valve.

**Fig. 2** Balls of ball valves – damage examples by stereomicroscope; a) – unstuck part; b) – adhesive particle; c) – damage by steam; d) – round depression

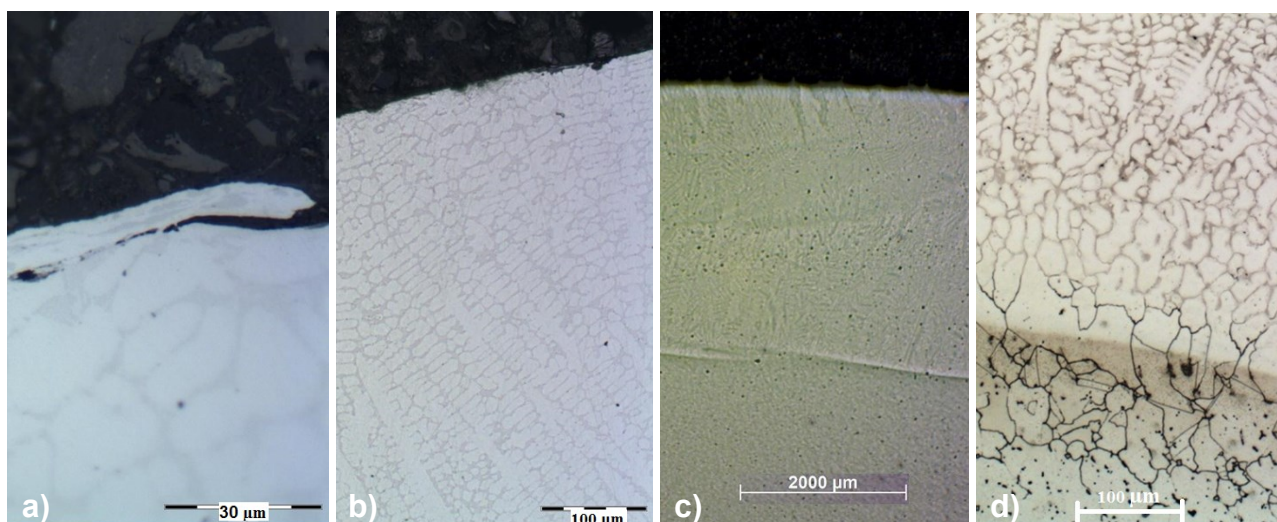
**Fig. 3** Metallography of balls; a), b) – types of surface damage; c), d) – cross section of welding layer

The metallographical evaluation was found to be the thickness of the welding layer in the range of 2 till 3 mm, for all of the components equipped with surfacing (A-C, E). Metallographic analysis (fig. 3 c, d) on the basic material expected standard austenitic microstructure with equiaxed grains, with a fairly homogeneous distribution of size. This one then connect in buttering layer, which gradually „ingrowing“ into the Stellite weld deposit. The microstructure of has the character of a cast "two-stage" structure with light dendritic formations (matrix) a interdendritic areas of darker contrast. Structure, with relatively high purity (micropurity), even with the occasional occurrence of particles based on carbides and nitrides. is also characterized by a high „effort“ to the preferred orientation of dendrites, often perpendicular to the geometric centre of the sphere. On parts with the greatest degree of surface damage seems to be subsurface and surface layer volumic richer on dendritic phase. Are also evident damage with stripped layers character and "foreign" adhesion layers (perhaps with oxide-corrosion origin). In the evaluation of the damaged surface areas have been identified heterogeneities, that is likely to arise when creating or finishing welded layer.

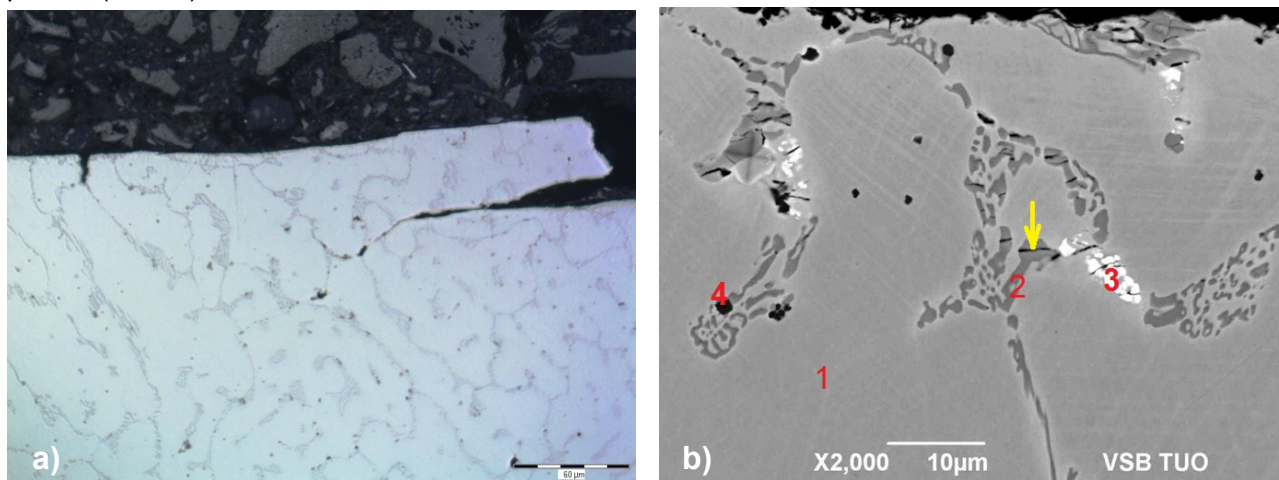
In the cross section of functional area of the valve seat was observed similar microstructure, as for balls. Only the thickness of the welding was somewhat less. An important finding is the fact that the place was found with significant damage (unstuck) of the surface layer with a unique initiation cracks in the area of eutectic interdendritic structure. Creates a significant large loose segments of the welded material, which may damage functional contact faces (fig. 4a). From the fractographical viewpoint was in the valve seat confirmed the assumption that to cracking the brittle interdendritic eutectic structure occurs, see fig. 4b. SEM analysis of valves seat more or less copies the others metallographic findings. In addition to the analysis of the basic phases were also detected by the minority particles of carbides and nitrides occurring in both phases (table 2).

**Fig. 4** Damage to the brittle structural components of seats welding layer, cracks in the eutectic phase; a) optical metallography; b) SEM analysis – the crack is marked with yellow arrow

The welding layer of the valve seat was somewhat thinner ( $< 2$  mm), however, they were detected in structural components with extreme hardness up to 1076 HV0, 01 – by analogy with the ball C. Their presence greatly limited their ability to transfer of the deformation. On microstructure pictures (fig. 4) and around indentations (fig. 7) were noticeable cracks, that extend across from these phases (on subsurface layer), connect with and finished at the open surface. From the character of the deformation damage in and around the indentations (movement of the slip bands) can be concluded on a very "intensive" stress-strain relations in the welded layer material, in particular eutectic phase (fig. 7). This problem would, of course, it deserves further study. [8, 9]

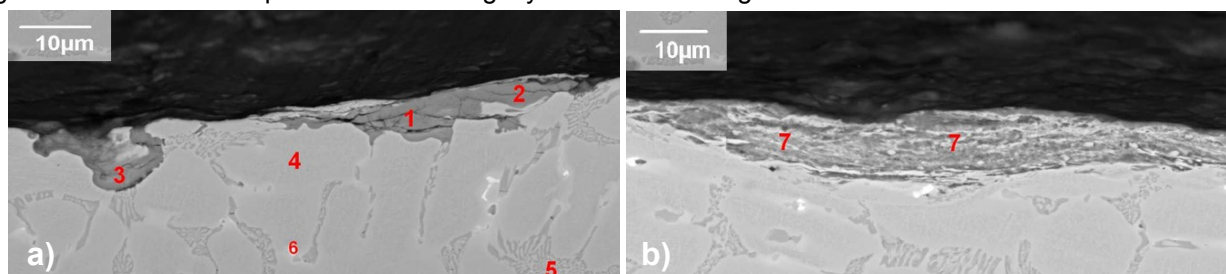
Evaluation of the surface showed the presence of "adhesion" units based on particular (complex) oxides of iron, chromium and cobalt plus depressions also (fig. 5a, b). Their chemical composition is on the table 3. SEM analysis of the composition of the welded material was confirmed standard chemical composition of Stellite significantly diluted with iron (in comparison with the standards requirements) for dendritic formations

a qualitatively similar, but quantitatively richer by chrome, composition of interdendritic eutectic structure, see fig. 5. The look and composition of buttering layer documented figure 6 and table 4.

**Fig. 5** Adhesive particles on the surface of Ball A

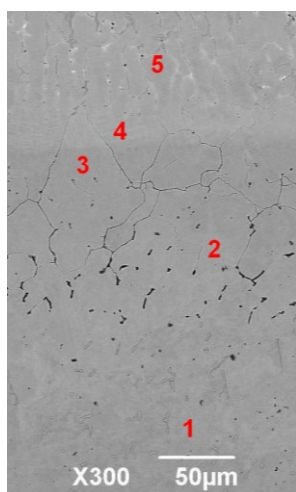
**Fig. 6** The scheme of buttering layer

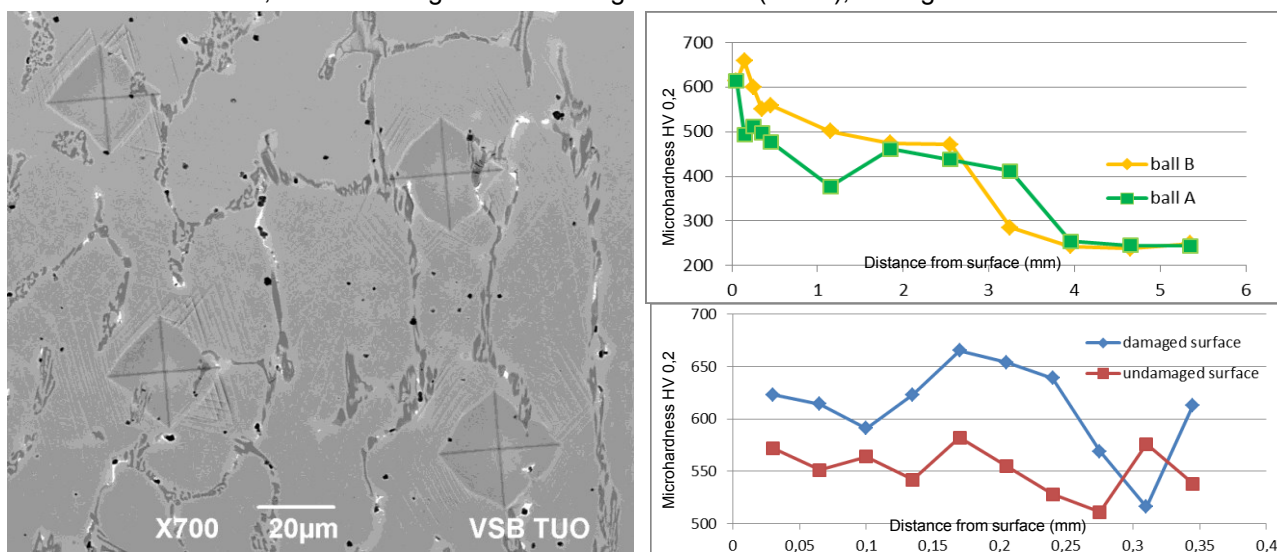
Measurement of microhardness in subsurface area of the working surface of the ball shows for values to around 580-620 HV<sub>0,01</sub>. The average hardness of welding to a depth of 0,3 mm from a functional surface was 525 vs. 545 HV<sub>0,2</sub> for undamaged vs. a damaged surface (ball A), see fig. 7.

**Fig. 7** Welding layer of valve seat - deformations near microindentations with cracks in eutectic phases (left); microhardness HV<sub>0,2</sub> of welding and buttering layer - comparison of ball A and B (above); hardness comparison of damaged and undamaged surface – ball A (below)
