STRUCTURAL DEGRADATION OF STEAM PIPE BEND MADE OF 0.5Cr-0.5Mo-0.3V STEEL AFTER LONG-TERM CREEP EXPOSURE

Material and Metallurgical Research, Ostrava, Czech Republic, EU

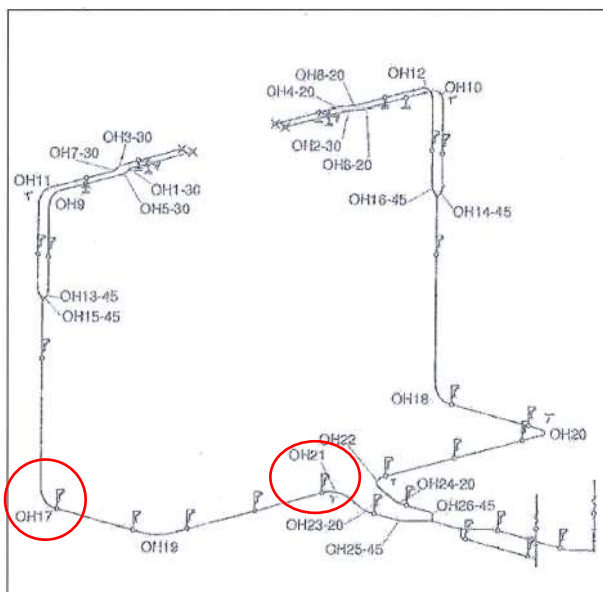
Damaged areas with cracks on the outer surface of two pipe bends were found during the planned inspection of the steam pipeline of a 200 MW boiler in a coal-fired power plant (see circles in Figure 1). The steam pipeline was made of pipes \varnothing 324 x 48 mm of steel grade 15 128.9 and was operated at 540 °C with a steam pressure of 17.3 MPa for more than 240,000 hours. In the case of bend No. 17 there was a large area affected by a mesh of cracks, while in the case of bend No. 21 the defective area was only local. In both cases the damaged areas were adjacent to the outer fibre of the bend, but did not directly lie on it.

Fig. 1 Scheme of left and right branch of the steam pipeline with damaged bends

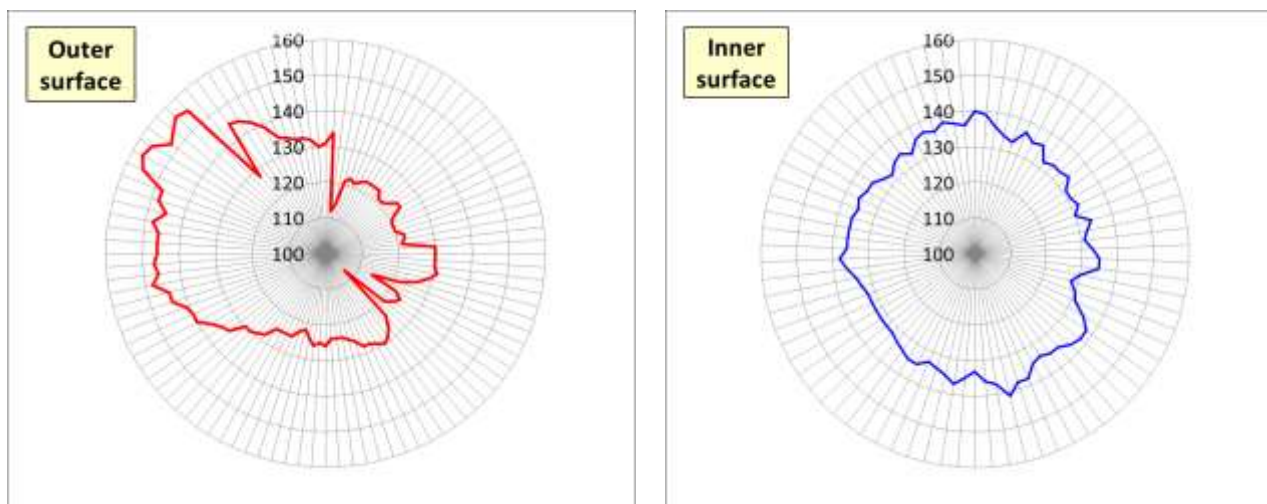
Hardness profile was also measured in the area of maximum damage of the bend either around the pipe circumference either through the wall thickness. Circumferential hardness measurement (HV 30) was carried out in three lines: close to the outer surface, in the middle of the wall thickness and close to the inner surface, in all cases with a distance 10 mm between the individual indentations. The results of the hardness measurement made in the outer and in the inner surface are shown in Fig. 2 and the local decrease in hardness in the area of defects on the outer surface is evident, while the hardness on the inner surface seems to be uniform around the whole pipe.

Fig. 2 Hardness profile HV 30 on the outer and inner surface of the pipe bend

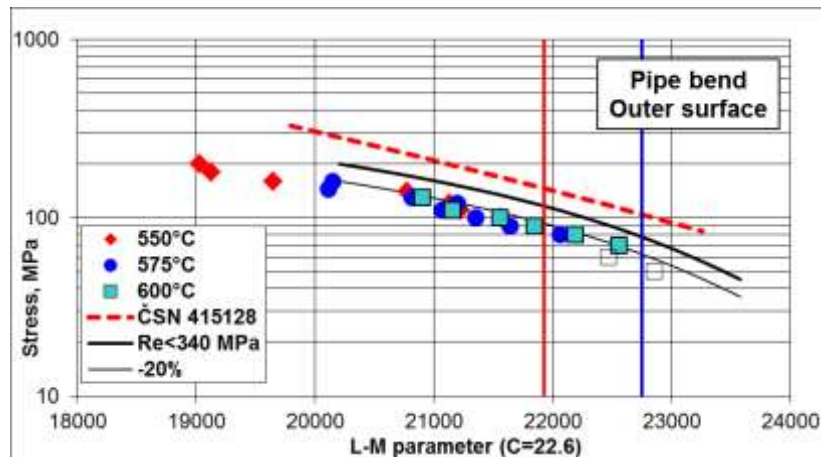
In order to determine the actual creep characteristics of the pipe bend, creep rupture specimens were machined from the material close to the outer surface of the pipe in the area adjacent to the cracks. Creep testing program was performed at temperatures 550, 575 and 600 °C. Although so far completed creep tests do not reach long times to fracture, the results being at disposal already allow an evaluation of creep rupture strength for at least 10,000 hours. For comparison of the obtained creep testing results with the standardized data of the mean creep rupture strength R_u , the results of individual creep tests were converted into Larson-Miller parameter P_{LM} [5]. The results showed that the actual value of creep rupture strength (CRS) at 550 °C for 10,000 hours is 87 MPa, while the median standard value of $R_u/550$ °C/10⁴ h for the 15 128 steel grade equals 146 MPa and the median $R_u/550$ °C/10⁴ h value of heats having yield point below 340 MPa drops down to 115 MPa. Thus, the actual CRS of the steam pipeline material is lower of about 40 % and 24 %, respectively, compared to the above stated values – see Fig. 3. Open symbols in this figure represent still running creep.

Fig. 3 Comparison of the results of creep tests with the values of CRS of the steel 15 128 for $Re < 340$ MPa

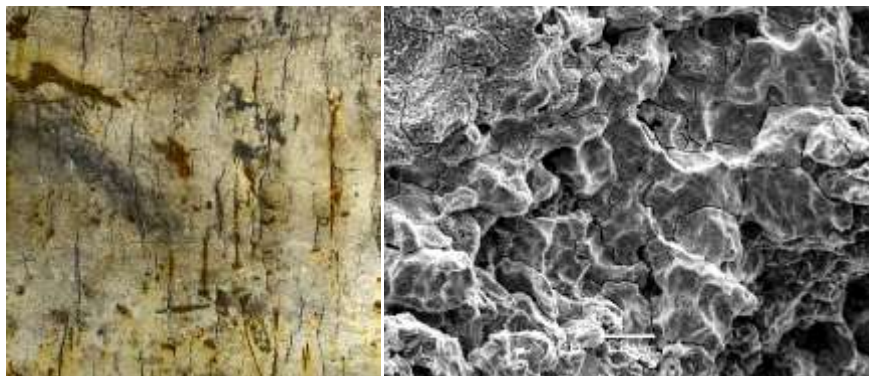
Figure 4 illustrates the appearance of the outer surface of the pipe and the fracture surface of the principal crack in the defective area. These cracks were numerous and were oriented principally in the axial direction of the pipe bend. The appearance of the cracks confirmed their creep origin. The cracks originated on the outer surface and propagated in the intergranular manner from the outer surface of the tube in the direction approximately perpendicular to the surface of the pipe.

Fig. 4 Network of cracks on the outer pipe surface and fracture surface morphology

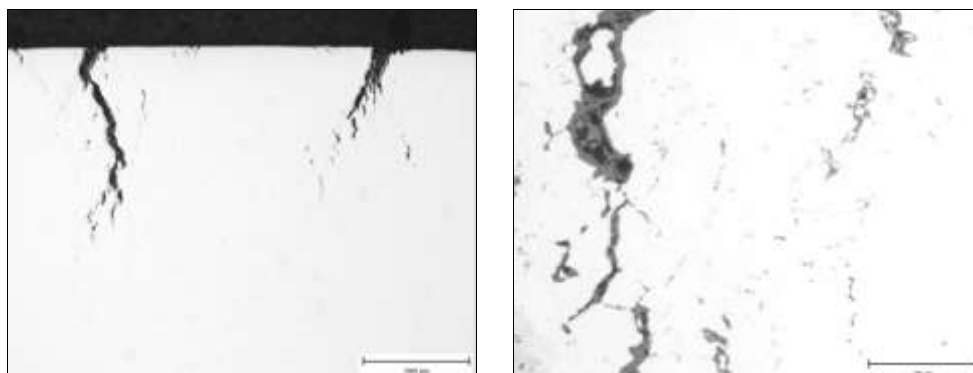
Crack surface was covered with the iron oxides on the outer surface of the pipe bend and during propagation towards the inner surface the branching of the cracks was observed, also covered with films of iron oxides. The total depth, in which the cracks propagated, was up to 7 mm below the outer surface, Fig. 5.

Fig. 5 Cracks partly fulfilled with oxidizes on the outer surface of the pipe

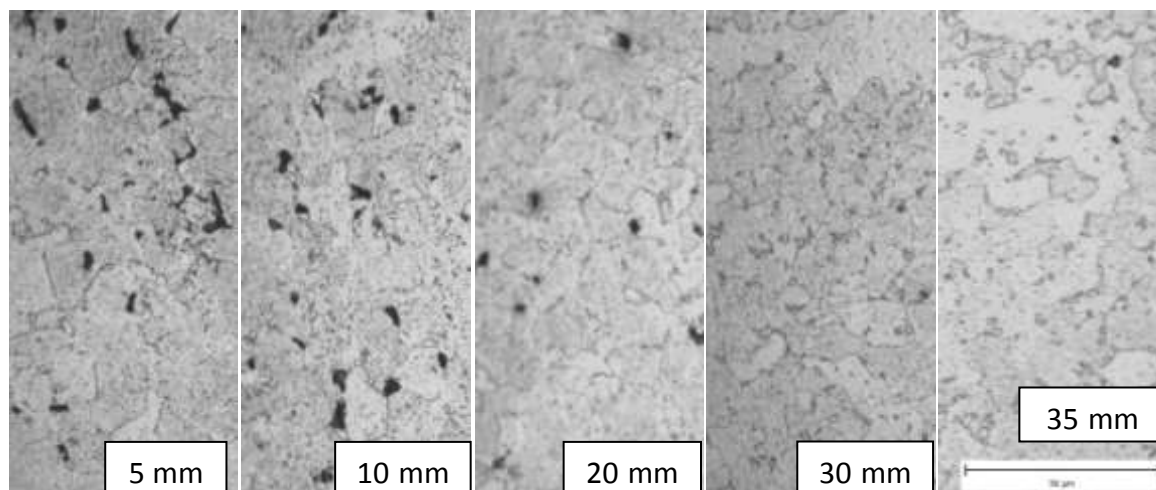
Microstructure in the area of creep cracks was fine-grained with tempered, ferritic-carbide structure, in the inner surface of the pipe the microstructure had features of tempered bainite. Beneath the outer surface was observed significant cavitation damage and its frequency decreased towards the inner surface - Fig. 6. 5 mm below the outer surface were found both coarse and isolated cavities and also cavity chain with the length up to 139 microns. 10 mm or more from the surface there were observed only isolated cavities. With further increasing distance from the outer surface, the proportion of cavities and also their size decreased – Fig. 6.

Fig. 6 Range of cavitation damage from the outer to the inner surface of the pipe bend

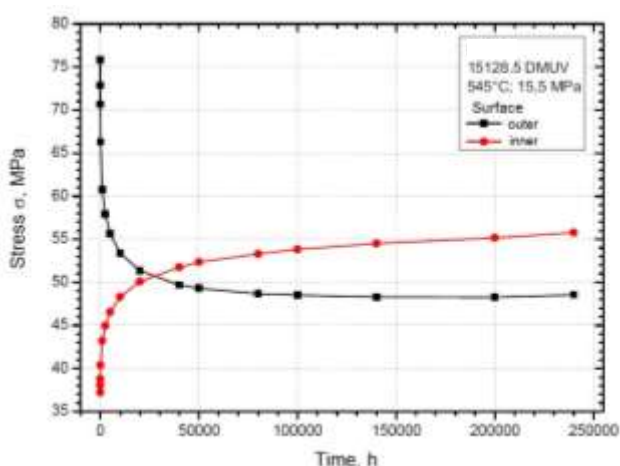
Calculation of the redistribution of initial elastic stress during operation of the evaluated bend was carried out by finite element method for the actual geometry of the pipe bend and the material with lower strength and deformation properties (DMUV material with the default yield strength under 340 MPa) [7]. The calculations showed very rapid stress redistribution in the initial state and localization of maximum tangential stress at the outer surface of the pipe bend. It means that the initiation of creep cracks can be expected on the outer surface and there is, therefore, a good chance to find them during the regular inspections – see Fig. 7.

Fig. 7 Redistribution elastic stress during bending operation

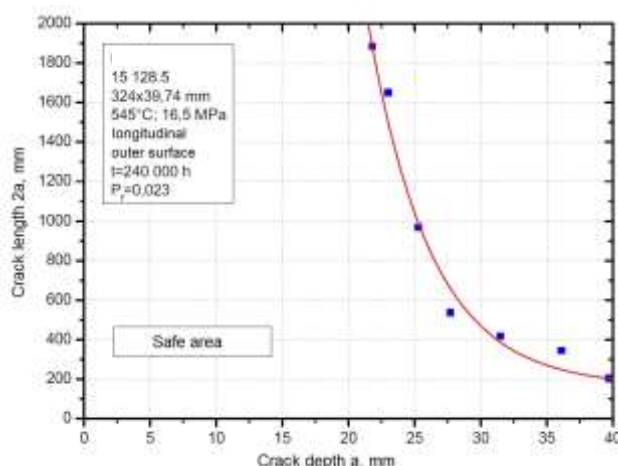
The critical crack depth for the initiation of the final fracture was determined for the actual values of the yield strength, ultimate strength and fracture toughness of the bend at 550 °C. The calculation was made for a considerable length of longitudinal cracks extending from the inner and outer surface of the bend depending on the risk of failure. Even for a low probability of fracture ($P_f = 0.001$) is the ratio of critical crack depth to the actual minimum wall thickness greater than 0.5, which means that the only cracks with a depth exceeding one half of the wall thickness can be regarded as dangerous – see Fig. 8. This result supports optimism about the safe operation of the steam pipes, as we can expect that the crack would be detected before it grows to this length.

Fig. 8 Relation between depth and length of the critical crack for sudden fracture
