## CRACKING OF FERRITIC STAINLESS STEEL TUBES DURING PRODUCTION PROCESS

### Abstract

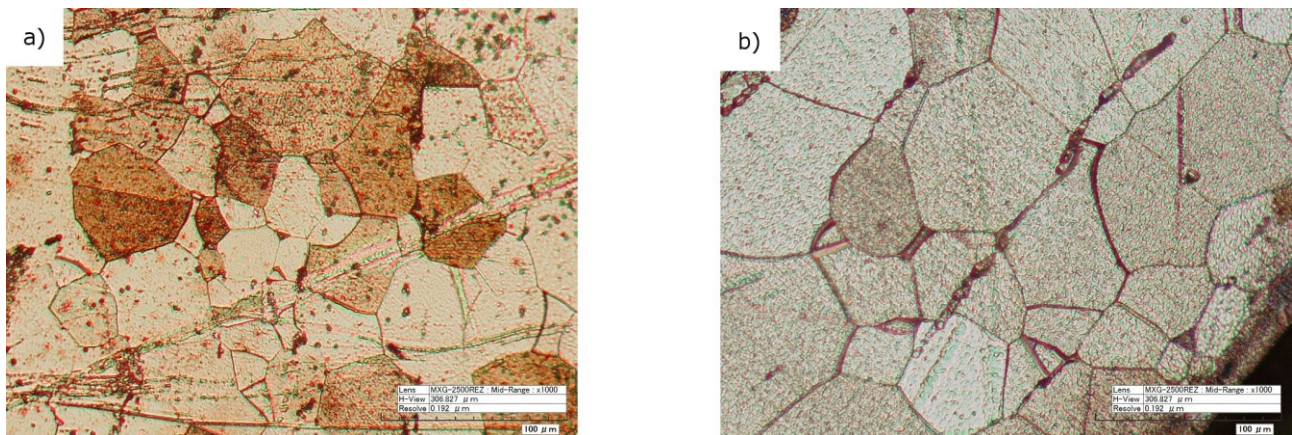
**Fig. 1** Cross section of the material showing needle-like structures and 1b

According to the literature studied [2-7] the needle-like structures seems to be delta ferritic structures. With one exception, the delta ferrite is present in austenite steels but should not be present in ferritic matrix, where the delta and alpha ferrite should be distinguished from one another, as these are generally same phase. To assure the material examined is ferritic and not austenite as might result from this semi-conclusion. The X-Ray diffraction of these samples was made.

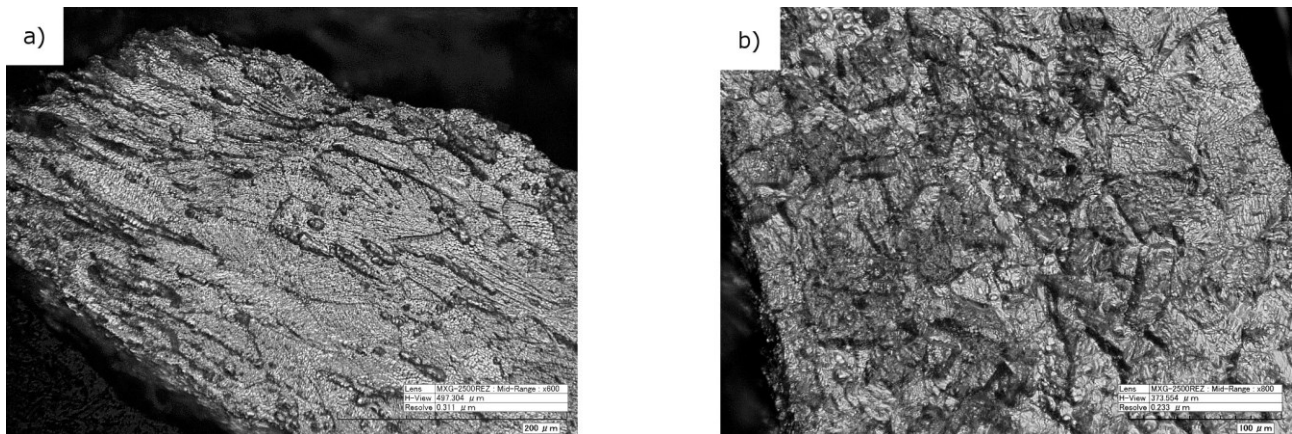
Primarily used Nital etching solution has proven itself to be insufficient to render the grains so the hydrochloric and nitric acid mixture was used (of 1:3 ratio) which proven to be able to render the grains. In addition needle-like structures were also shown on the etched cross sections, not originally present on the cross sections itself (as shown on fig 1). In addition it was also found, the deformation of the structure has only short range effect, at longer distance (600µm and more) the grains were not deformed at all. This is clearly visible on the fig. 2

**Fig. 2** Cross section of the failed tube showing elongation of the grains (2a) in near vicinity of the defect but 600 µm away there is no sign of deformation (2b)

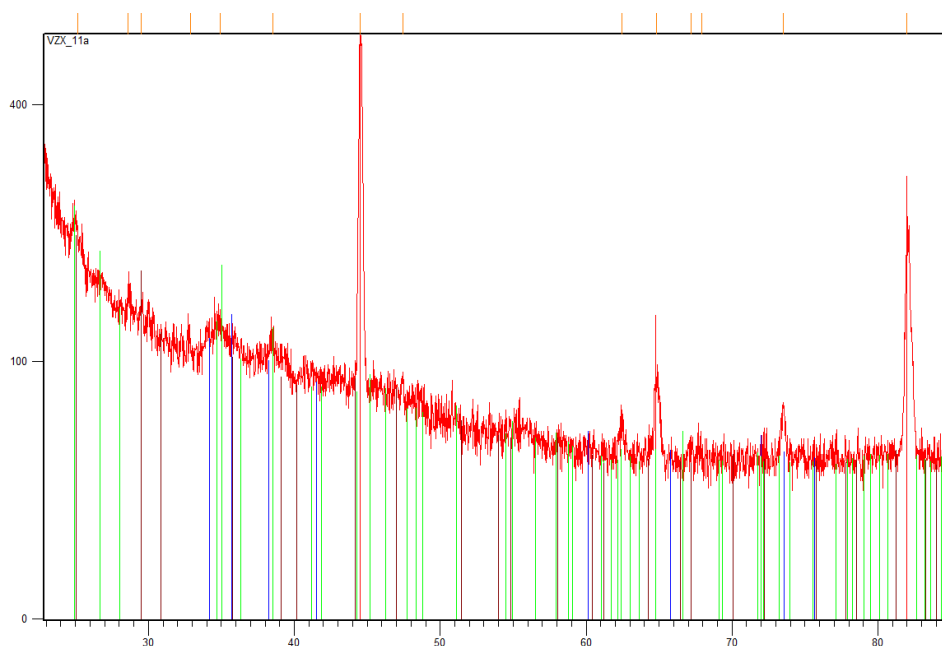
Using the XRD material was identified as AISI 434L which is similar in composition to AISI 444 as it was declared by manufacturer (XRD scan shown on the fig 3, whereas the compositions are shown on tables 1 and 2). At this point should be noted, the producer of tubes is not a producer of steel sheet. As shown in tables

below, the composition of those two ferritic steels varies slightly and the misinterpretation of the given material is more likely caused by inhomogeneity in the material in combination with the capabilities of the used method. In addition to ferritic steel (red lines), presence of silicon carbide (green lines) was found in the samples. This is no doubt caused by the presence of SiC, however this should be handled with caution, as the XRD scan contains some noise and also the SiC was used during the sample preparation (grinding and polishing) among other agents.

**Fig. 3** XRD scan of the material

We suppose there is some small amount of SiC present in the structure, but its exact amount, and thus the amount of carbide in the structure, should be determined by other method, to overcome the possible false positive identification caused by the noise (and also using different grinding materials if applicable).

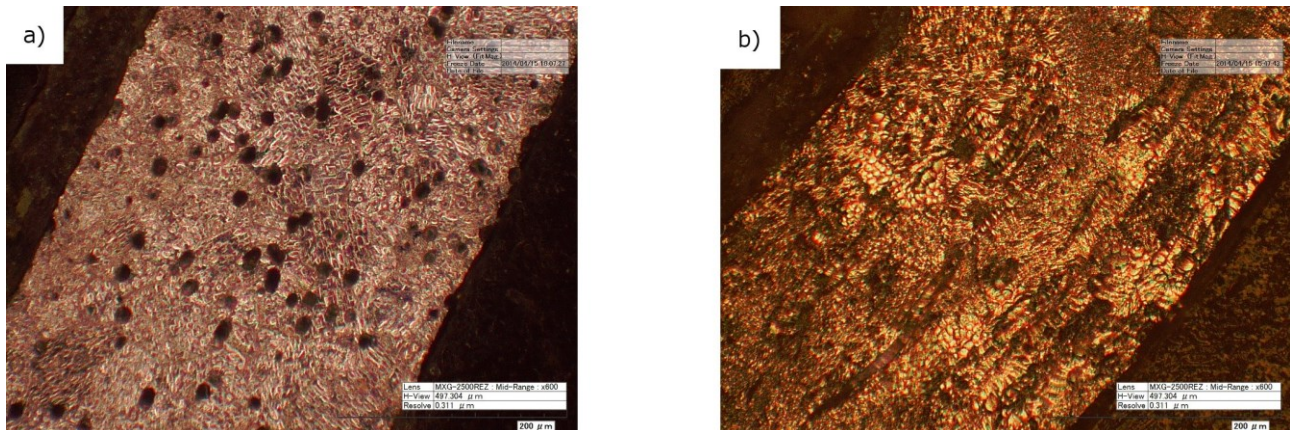
Also additional interesting fact was found during the optical microscopy (as shown on fig.4). The needle-like structures are oriented parallel to the axis of rolling. On the cross section parallel to the axis the structures seems like scratches, on perpendicular the seems like holes drilled into the material. Also on the parallel cross section the needles seem to copy the shape of the sheet, when the sheet was bend, the needles bend in appropriate direction.

**Fig. 4** Cross section parallel (4a) and perpendicular (4b) to the rolling axis.
