HIGH TEMPERATURE HOT CORROSION BEHAVIOR OF SELECTED THERMALLY SPRAYED COATINGS ON X22 STAINLESS STEEL IN AN AGGRESSIVE ENVIRONMENT AT 750 °C

Abstract

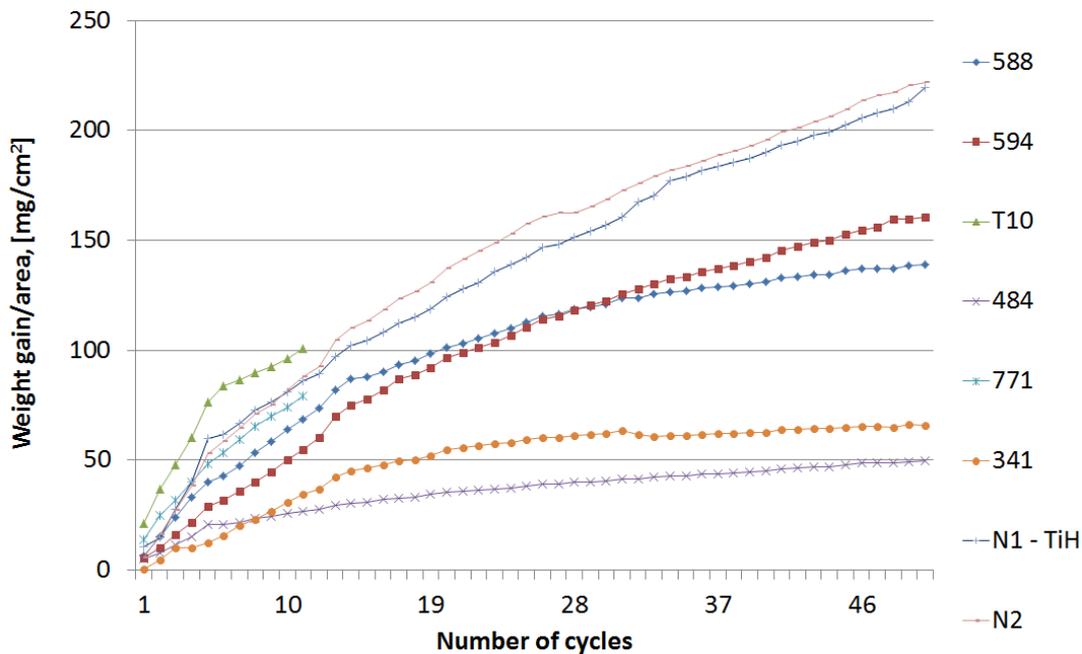
The graph of weight gains of individual evaluated coatings in Fig. 1 shows how coatings behaved in aggressive environment of high temperature corrosion. Coatings marked as 771 and T10 exhibited in the 11th cycle total destruction and therefore no further results are included in this paper. The graph shows that nitride surface treatment exhibited the highest weight gain. Further, high weight gain show both carbide coatings and the lowest weight gain was exhibited by alloy based coatings marked 341 (Hastelloy C-276) and 484 (Stellite 6). The obtained results proved that the best performance in selected corrosive environment exhibit alloy based coatings and the worst exhibited the nitrided surface treatment. These results are consistent with other experiments already conducted under the same conditions. Furthermore, the paper includes also photographs made by SEM with tables describing elemental composition determined using EDAX analysis. Fig. 2 presents the microstructure of the Cr_3C_2 -CoNiCrAlY in cross section after the exposure to corrosive environment. The photograph shows evident mechanism of corrosion damage and the disruption proceeding from coating surface. The oxide layer formed on the coating was degraded by molten salts. Consequently, the coating lost its oxide layer and degraded from the surface. Fig. 3 presents the microstructure of the Cr_3C_2 -NiCr coating in cross section after the exposure to corrosive environment. The photograph shows evident mechanism of corrosion damage where the disruption of coating processed from the surface similarly as previous Cr_3C_2 -CoNiCrAlY carbide coating. Oxide layer was formed and reacted with molten salts resulting in corrosive attack on the coating.

Fig. 1 Weight gain/area vs. number of cycles plot for the bare and HVOF spray coated X22 steel subjected to molten salt environment ($Na_2(SO)_4 - 60\%V_2O_5$) at 750 °C for 50 cycles.

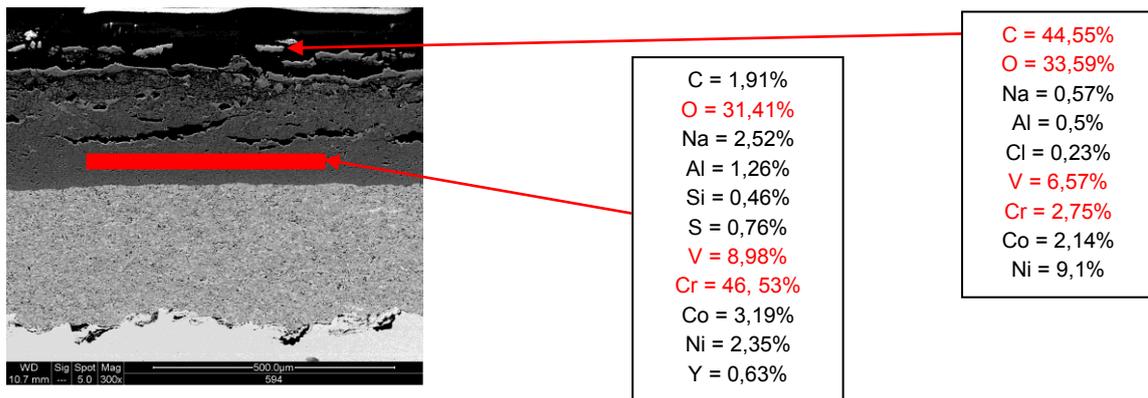
Fig. 2 Cr₃C₂-CoNiCrAlY coating after the exposure at the temperature of 750°C in corrosive environment of molten salts Na₂(SO)₄ – 60%V₂O₅ after 50 cycles

Fig. 4 shows the microstructure of TiMoCN-Ni coating in cross section after the exposure to corrosive environment. The photograph evidently shows the corrosion damage mechanism resulting in total coating destruction, most likely caused by high temperature. There were most probably created new phases and oxides with higher volume and this change resulted in coating destruction. It proved that this coating is not suitable for high temperature applications. Fig. 5 presents the microstructure of Stellite 6 coating in cross section after the exposure to corrosive environment. The photograph apparently shows the mechanism of corrosion damage based on the formation of oxides on coating surface. These oxides reacted with salt

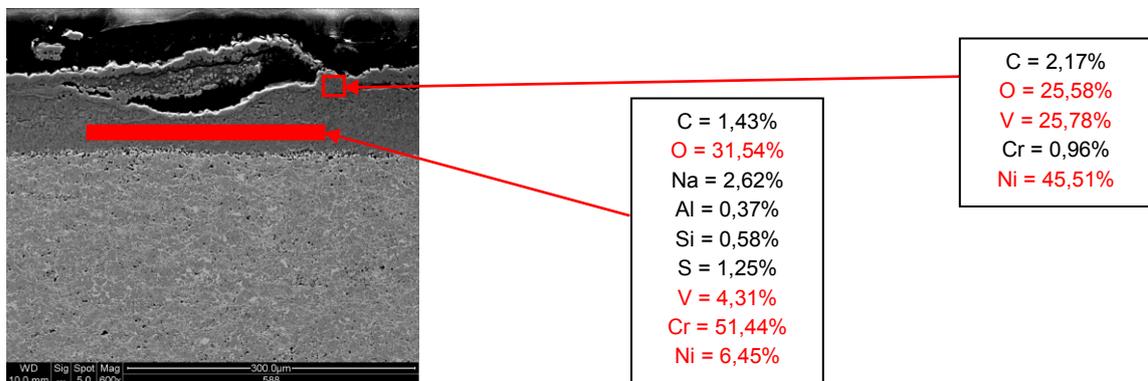
Fig. 3 Cr₃C₂-NiCr coating after the exposure at the temperature of 750°C in corrosive environment of molten salts Na₂(SO)₄ – 60%V₂O₅ after 50 cycles

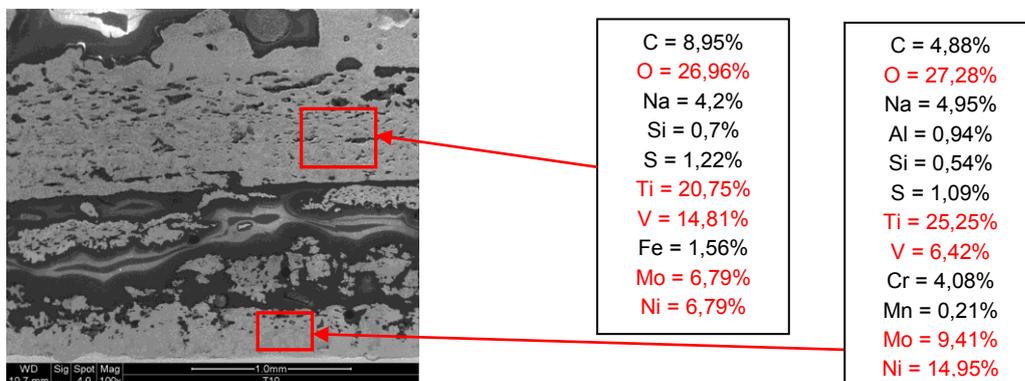
Fig. 4 TiMoCN-Ni coating after the exposure at the temperature of 750°C in corrosive environment of molten salts Na₂(SO)₄ – 60%V₂O₅ after 50 cycles

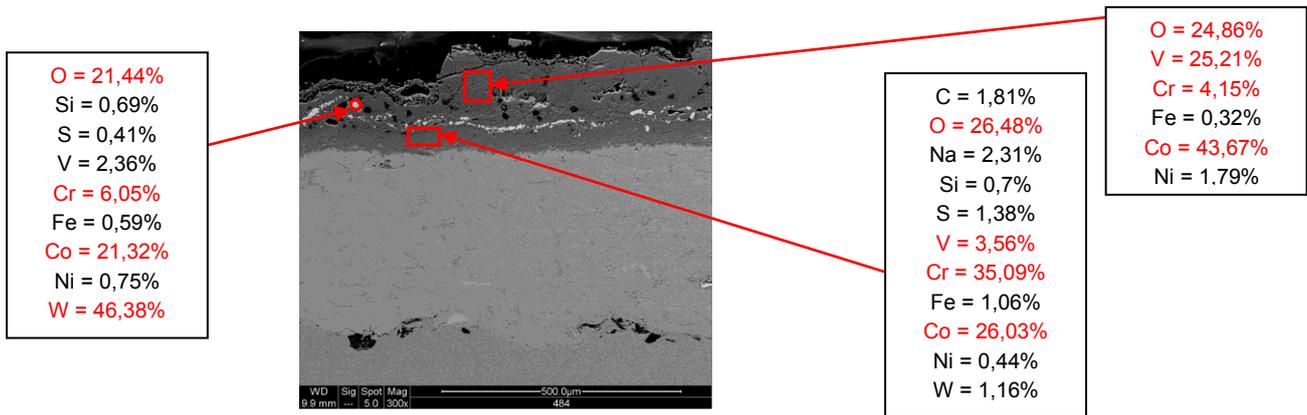
Fig. 5 Stellite 6 (CoCrW) coating after the exposure at the temperature of 750°C in corrosive environment of molten salts $\text{Na}_2(\text{SO})_4 - 60\% \text{V}_2\text{O}_5$ after 50 cycles

mixture resulting in attack of individual splats on the coating surface. However, the corrosion attack on this coating is negligible. Fig. 6 presents the microstructure of Hastelloy C-276 coating in cross section after the exposure to corrosive environment. The photograph shows the same mechanism of corrosion damage as Stellite 6 coating. It can be said that these coatings exhibit very similar corrosion mechanism. Fig. 7 shows the microstructure of NiCrBSi coating in cross section after the exposure to corrosive environment. This coating exhibited very aggressive attack. Both the thin oxide layer and the coating were damaged. Based on the achieved results, this coating is not suitable for this type of corrosive environment. Fig. 8 shows cross sections of nitrided steel with and without surface activation using TiH prior to the nitriding. The nitrided layer did not manage to protect the underlying material from corrosive attack.

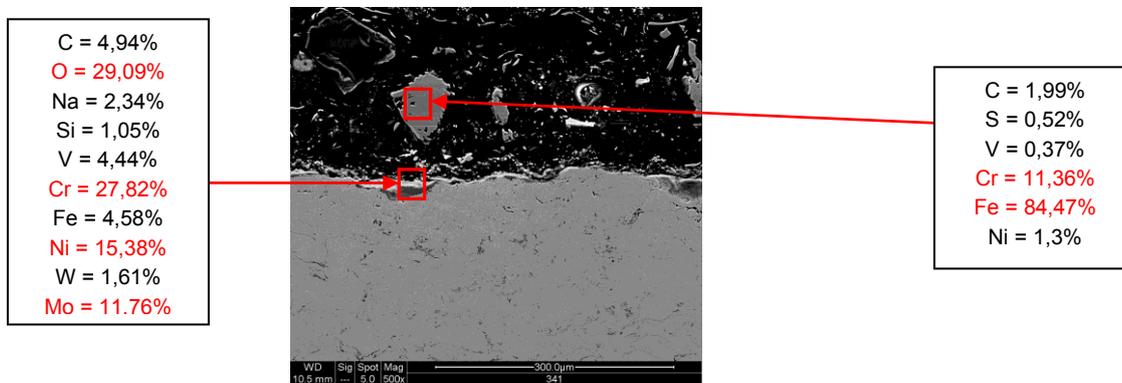
Fig. 6 Hastelloy C-276 (NiCrMoW) coating after the exposure at the temperature of 750°C in corrosive environment of molten salts $\text{Na}_2(\text{SO})_4 - 60\% \text{V}_2\text{O}_5$ after 50 cycles

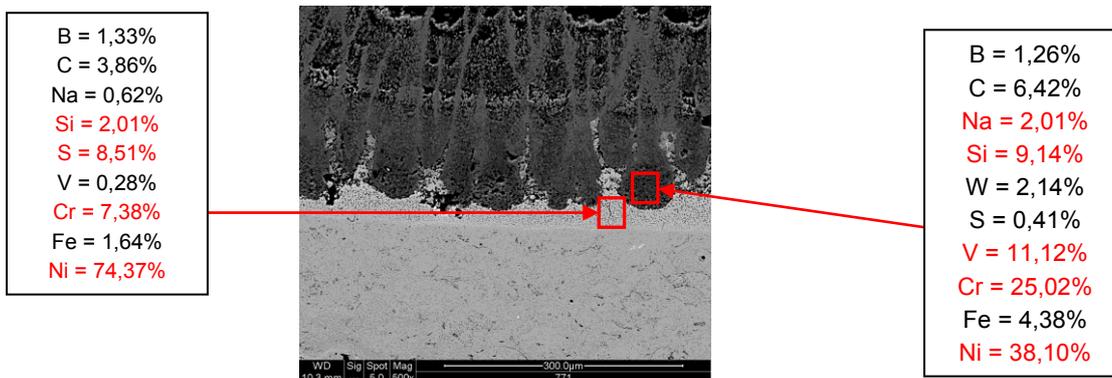
Fig. 7 NiCrBSi coating after the exposure at the temperature of 750°C in corrosive environment of molten salts $\text{Na}_2(\text{SO})_4 - 60\% \text{V}_2\text{O}_5$ after 50 cycles

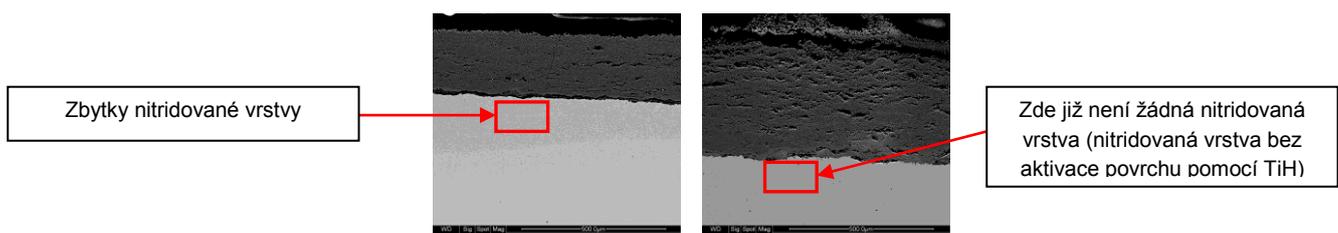
Fig. 8 Nitrided steels after the exposure at the temperature of 750°C in corrosive environment of molten salts $\text{Na}_2(\text{SO})_4 - 60\% \text{V}_2\text{O}_5$ after 50 cycles
