LIFE ASSESSMENT OF HIGH PRESSURE STEAM PIPING BEND WORKING UNDER CONDITIONS OF CREEP DAMAGE

This article deals with a lifetime assessment of one steam piping bend made of ČSN steel 15 128 (14MoV6-3) which was operated in conditions of creep damage in Czech fossil fuel power plant until its creep deformation obtained a limit of 1 percent. The overall condition of the bend was assessed using replica and cross section metallography including electron microscopy and by evaluation of mechanical properties in as-received state and after additional laboratory ageing at 600 °C for up to 5 000 hours in air conditions. As the final result, the residual lifetime by using mathematical approaches and standards was estimated.

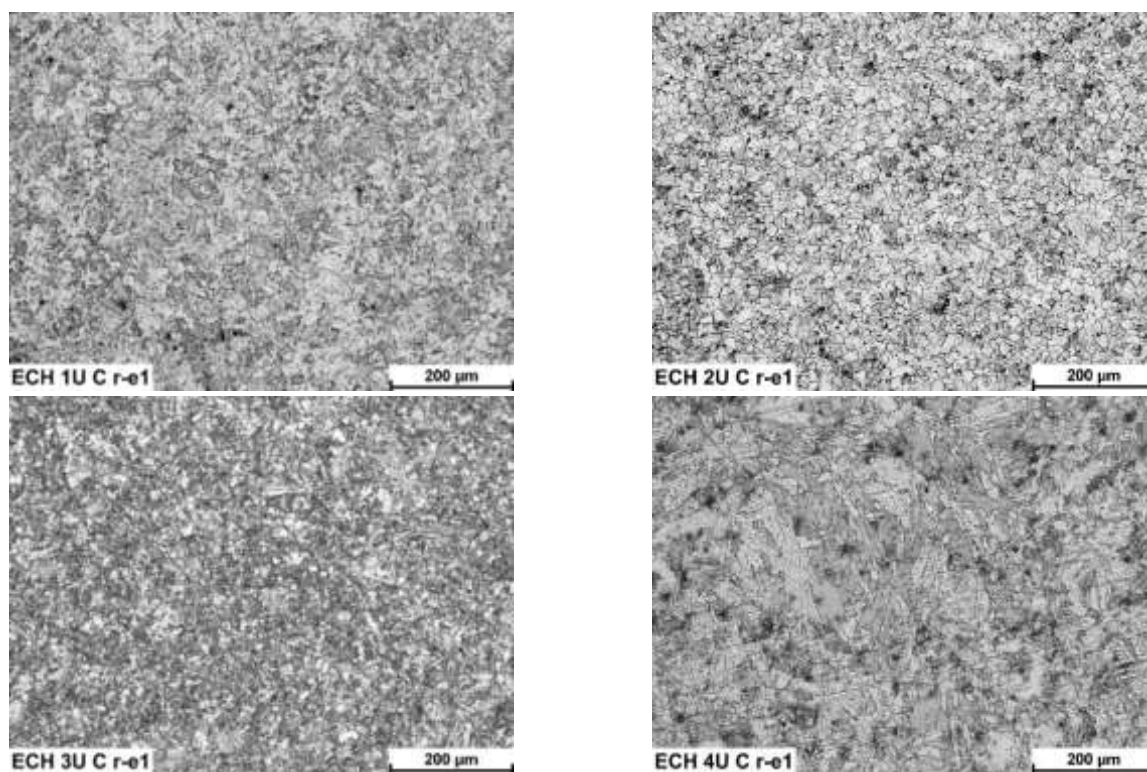
Fig. 1 Comparing of microstructure on the outer surface of area under tension in various position of bend.

Depending on the sampling position (position on inlet of steam into the bend, position of maximum bending and position on outlet of the bend) different degree of degradation of the bainitic-ferritic microstructure was observed. The microstructure at the position on inlet of steam into the bend (ECH1 ring) and at straight part outside of the bend (ECH4 ring) was formed with tempered bainite with a maximum 5 % proportion of ferrite with a grain size G7 to 8, without creep cavities. Minimum degraded bainitic microstructure was at position on outlet of the bend (ECH3 ring) formed by bainite with local occurrence of pure ferrite with grain size G9, without creep cavities. In the Figure 1 comparison of microstructure on the outer surface of the area under tension in various position of steam pipe bend is documented. Conversely, the most degraded microstructure was detected at position of maximum bending in the area under tension (ECH2C) and towards neutral axis (ECH2A) formed by strongly tempered bainite with 65 % of ferrite with grain size G6 to 7. Also numerous creep cavities oriented at grain boundary were present, see Figure 2. According to ERA technology standard the degree of degradation of this microstructure at the position of maximum bending in area under tension corresponds to class D and the degree of cavitation damaged according to VGB TW-507e standard corresponds to class 2b. Therefore, the resulting residual lifetime of steam piping bend will be determined by the material properties from position of maximum bending. In addition, quantitative stereology was carried by using scanning electron microscope which provided an information on the distribution of chromium carbides at grain boundaries and vanadium carbides within grains. This distribution has an influences on the mechanical properties.

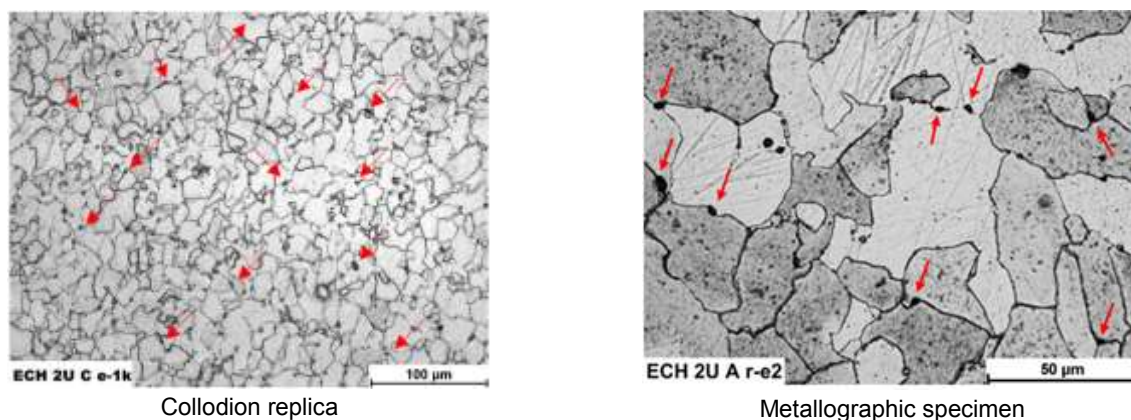
Fig. 2 Cavities in place ECH2A and ECH2C on the outer surface

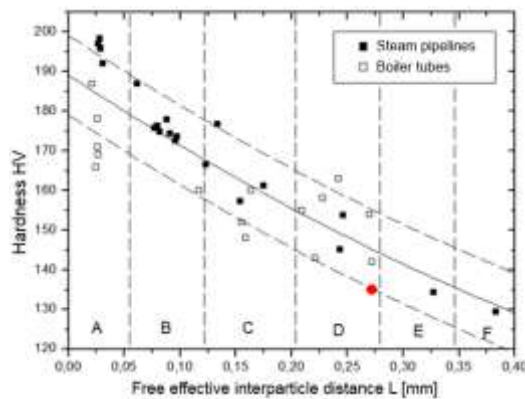
Fig. 3 The dependence of hardness at free effective interparticle distance at position ECH2C

The measured values of mechanical properties were compared with empirical data for steel 15 128 taken from [2] (see Figure 3), with free effective interparticle distance and with classification of degradation microstructure according to ERA Technology too, see Figure 4. The Figure 4 shows that the measured hardness and free effective interparticle distance corresponds to a defined stadium of degradation microstructure D.

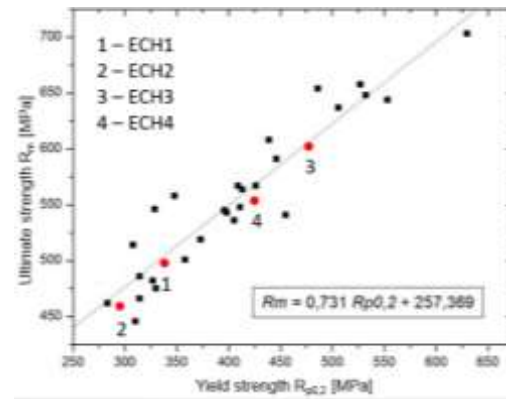
Fig. 4 The dependence of ultimate strength at yield strength (red dots belong to our experimental material)

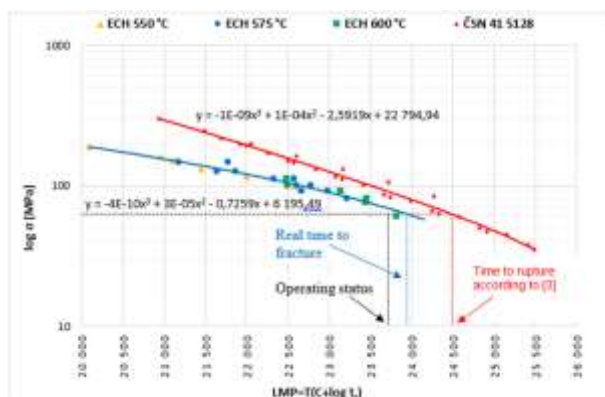
Fig. 5 Estimation of residual lifetime using parameter LMP

Dependence of stress versus LMP was constructed from data in document [3] (see a red curve in Figure 5) and data from creep-rupture test, from document [4] (see a blue curve in Figure 5). Creep-rupture test was performed on samples collected from the outer and inner surface near of maximum bending the steam piping bend.

The Figure 5 shows that the values obtained from creep rupture test of samples show lower creep rupture strength than the standard [3] specifies. The material is already degraded and therefore it can be expected that the residual lifetime will be significantly shorter than in the case of estimation from standard data [3].

The value of the residual lifetime of the data mentioned in the document (not operated material) [3] were estimated from the red curve and value of residual lifetime is 1 393 231 hours (159 years). The value is definitely not real, because it is too high. But residual life estimated from the blue curve is 159 972 hours (18.3 years) that is much more likely. So, this results lead us to the conclusion that the steam piping bend was about half of the total life

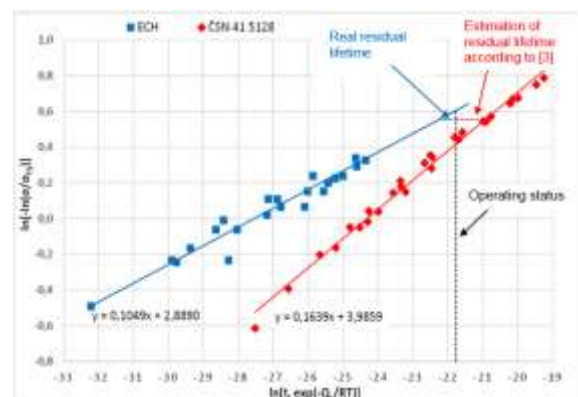
Fig. 6 Estimation of residual lifetime using Wilshire equation

The input data was the same as in the case of evaluation according to LMP. An equation (1) was used for a construction of a time dependency of stress, shown in Figure 6.

Into the equation (1), operation parameters of steam piping bend as operating time t_f 184 969 hours, operating temperature T 543 °C and operating stress σ 62.7 MPa (converted for tangential stress) in a ratio of the measured ultimate strength at temperature 540 °C (σ_{TS} =358 MPa) were input.

As for with LMP parameter, residual lifetime from red curve for standard data [3] and from blue curve for experimental data was estimated. The residual lifetime is 243 483 hours (27.8 years) for red curve and -71 225 hours (-8.1 years) for blue curve respectively. These results certainly does not correspond to the reality at all.
