INFLUENCE OF HVOF SPRAYED COATINGS ON FATIGUE PROPERTIES OF COATING-SUBSTRATE SYSTEM

Abstract

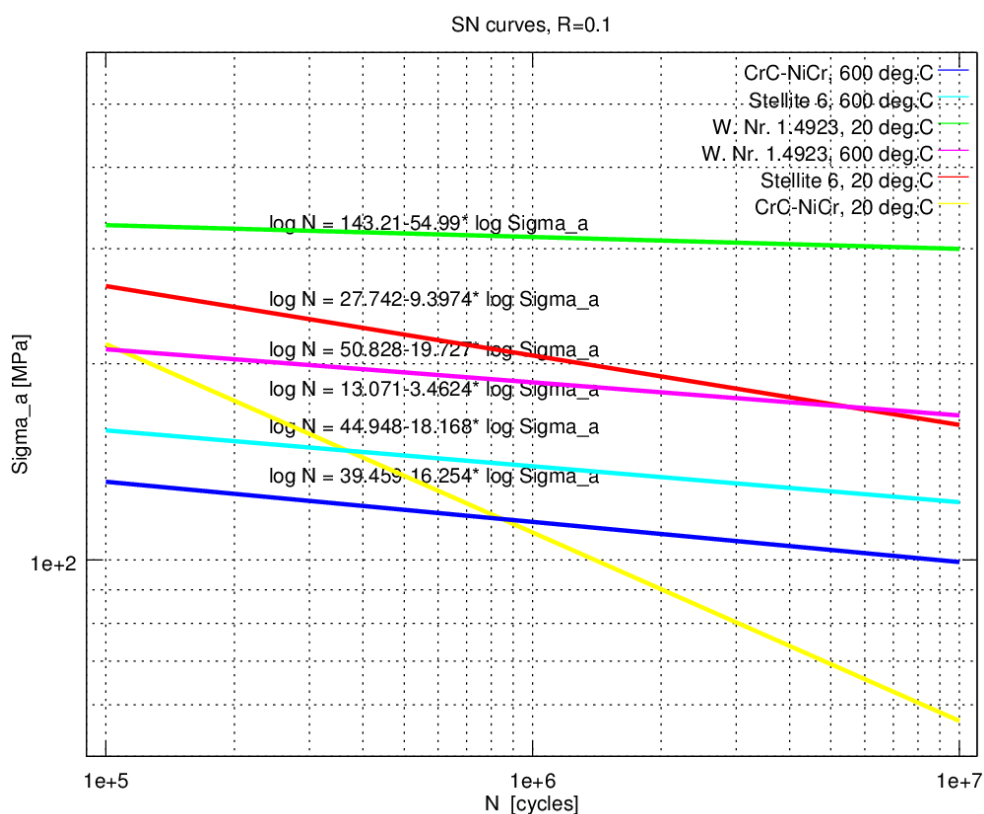
This section presents the results of axial fatigue testing. The results are presented as comparative chart of the measurements. Table 1 presents numeric average values of fatigue life for each system and the substrate individually. For calculation of the fatigue life limit was used equation $N=a\sigma^b$, which could be rewritten in form of $\log N=a+b\log\sigma$. Final S-N curves can be clearly seen in Fig. 1, which includes the results for the system of coating/substrate and for the substrate itself. All S-N curves are assembled in dependence on stress amplitude, not on the maximum stress.

Fig. 1 S-N curves representing all tested sample sets

We can state that conducted research corresponds with the trends mentioned in [2] and [9]. Based on the results of fatigue tests it is possible to say that coated systems exhibit decreased fatigue properties than substrate itself. This fact is very well confirmed by the image (Fig. 1), which compares the different systems at different temperatures along with the substrate material.

Looking on the fatigue life of the substrate itself, it is clear that at 600 °C there is a decrease of almost 50%. This effect is associated with the change of mechanical properties, which corresponds with change in the slope of S-N curve.

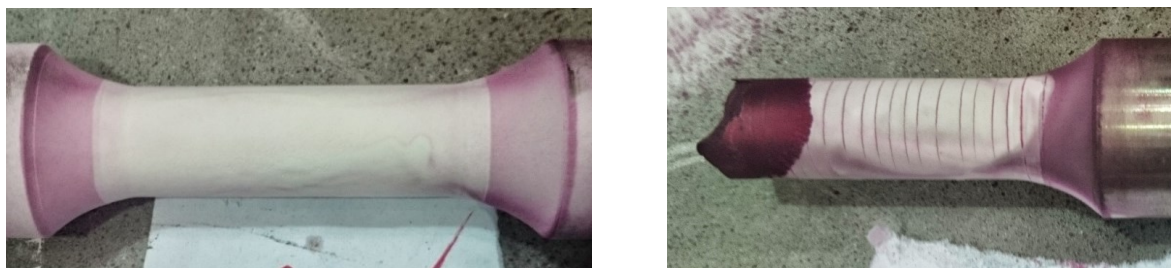
Below the stress of fatigue life limit the system coated by Cr₃C₂-NiCr powder at 20 °C showed that it can fully withstand fatigue damage and there is no formation of micro-cracks along whole length of the sample. Illustrative photograph of the sample is shown in Fig 3. In the case of a stress above the fatigue life limit the system coated by Cr₃C₂-NiCr showed formation of micro-cracks along the entire length of the sample. Micro-cracks indicated by capillary test are shown on the following figure (Fig. 3). It has been shown that the coating Cr₃C₂-NiCr is not able to resist the stress conditions and relaxes in form of segmentation into annular shapes. It means that coating is not able to effectively protect the part above the fatigue life limit. Samples coated by Cr₃C₂-NiCr subjected to axial fatigue test at 600 °C shown that under these conditions the coating is capable of fully withstanding the conditions of the test and exhibits no micro-crack formation or other degradation. Samples coated by Cr₃C₂-NiCr at elevated temperature and at higher stress load revealed a surprising result. Unlike the same conditions at 20 °C samples at 600 °C withstand those conditions and capillary test demonstrated that the fatigue damage does not support formation of micro-cracks followed by segmentation of the coating. The results prove that Cr₃C₂-NiCr coating is better able to operate and protects the substrate at elevated temperatures up to a stress load 50% higher than the fatigue life limit.

Fig. 3 Capillary testing of $\text{Cr}_3\text{C}_2\text{-NiCr}$ coating at 20 °C (Left – sample with load under the fatigue life limit, right – sample above fatigue life limit)
