THE TRANSFORMATIONS MORPHOLOGY BY CAVITATION EROSION OF GAS NITRIDED X2CrNiMoN22-5-3 DUPLEX STAINLESS STEEL

Lavinia Madalina MICU¹, Ion MITELEA², Ilare BORDEASU³, Corneliu Marius CRACIUNESCU⁴,
Octavian Victor OANCA⁵

„Polytechnica“ University of Timisoara, Mihai Viteazul No.1, 300222 Timisoara, Romania,

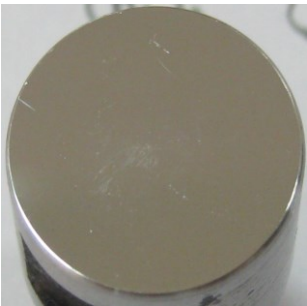
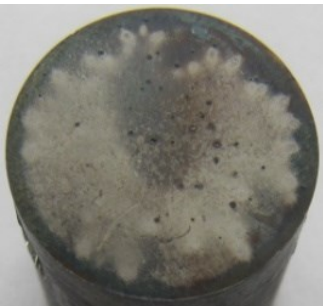
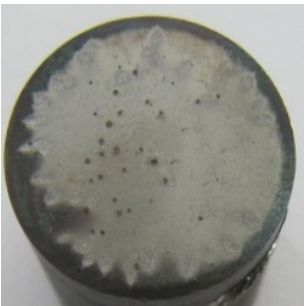
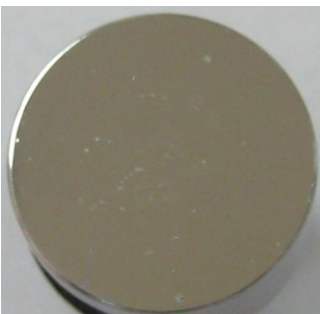
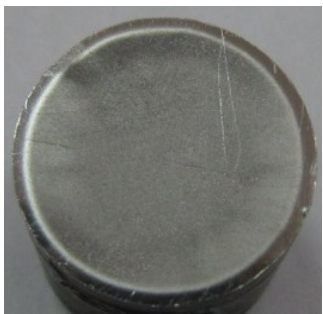
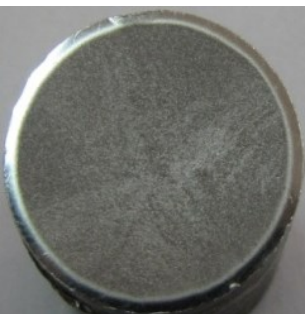
Table 3 Images of the eroded surface after diferent cavitation attack duration

Treatments	Minut attack		
	0	90	165
Nitrided in gas

Solution annelead

The higher resistance at the cavitation attack, on the research duration is also confirmed by the images of the eroded surface, presented in Table 3, after 90 and 165 minutes of cavitation attack. It is to note the florist degradation mode of the gas nitrided surface, different of the annealed probe surface that is aproximately circular. The explanation is given by the nonhomogenous hardness dispersion in the nitrided layer, the harder area being harder to destroy by erosion. Random caverns in the nitrided surface are to be also noted in contrast to the degradation of the annealed probe surface which is more homogenous with uniform distributed pittings on the whole eroded surface. This degradation mode is explained by the morfology of transformations that are produced in the surface structure under the impact of microjets and shock waves.
