EFFECT OF ROLLING CONTACT FATIGUE ON THE ELASTIC-PLASTIC RESPONSE OF HADFIELD STEEL

SCHMIDOVA Eva, CULEK Bohumil, KAYA Utku

University of Pardubice, Jan Perner Transport Faculty, Pardubice, Czech Republic, eva.schmidova@upce.cz

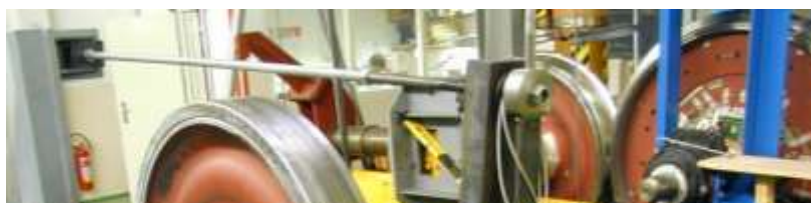
Fig.1 Rolling-contact fatigue testing equipment, detail on holder for set of tested samples

Samples for the analyses of actual degradation mechanisms were cut out from a railway switch in position, where the contact track was 40mm in width, i.e., in a position characterised by high dynamic operation loading. The chemical composition of the tested Hadfield steel was in full accordance with the standard EN 15689. The degradation process was simulated by a specialized wheel-test rig which enables rolling contact loading at a defined ratio between contact pressure and longitudinal slip. The contact was induced between a wheel 920mm in diameter and a special sample holder - a disk 136mm in diameter. The principle of the test is displayed in Fig. 1. The tested samples can be pulled out from the holder during the test and can be subjected to complex material analyses in chosen stages of the fatigue test. The presented test focused on the degradation mechanism in defined stages of the rolling-contact loading, so the evaluation consisted of the following parameters: surface hardening (in HV10 hardness values), depth of the plastic zone, character and depth of the surface damage (i.e., the slope and depth of the surface microcracks) and wear rate, measured by the weight loss between defined steps of the loading. The test was performed at contact pressure $P_{max} = 1140\text{MPa}$ and relative longitudinal slip $s = 1\%$. The dynamic response of the Hadfield steel was evaluated in two conditions - after the typical fabrication process vs. after the explosive hardening process. The influence of explosive hardening on degradation mechanisms was assessed within this experiment.

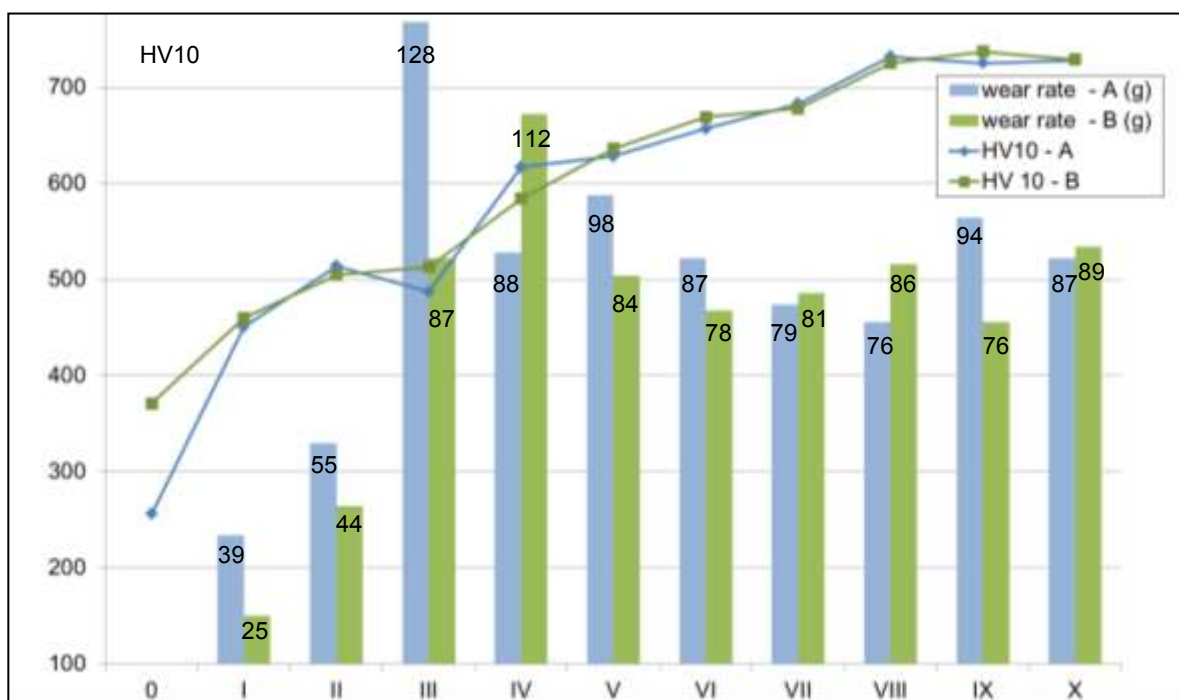
Fig.2 Hardening process vs. wear rate induced by experimental contact loading, in HV10 values (A...samples without explosive hardening, B... samples after explosive hardening)

Deformation hardening of surface layers was evaluated per 100 thou. cycles; average values from 3 measurements of each of the 4 samples' surfaces are shown in Fig 2. Intensive surface hardening was induced in the early stage of loading for both states of Hadfield steel. A sharp rise in hardness together with minimal wear appeared during the first 200 thou. loading cycles. At about 300 thou. loading cycles the biggest weight losses were ascertained for both compared states of the Hadfield steel, and earlier onset of intensive wear for material without explosion hardening. The tip of the observed wear progress was slightly moved to the higher loading cycles, and the global wear range of the steel after explosive hardening was lower compared to the material without prior hardening. A similar gradient of hardening depending on the number of loading cycles was ascertained up to approximately 800 thou. cycles. Saturation of the hardening vs. wearing processes occurred during subsequent loading cycles.

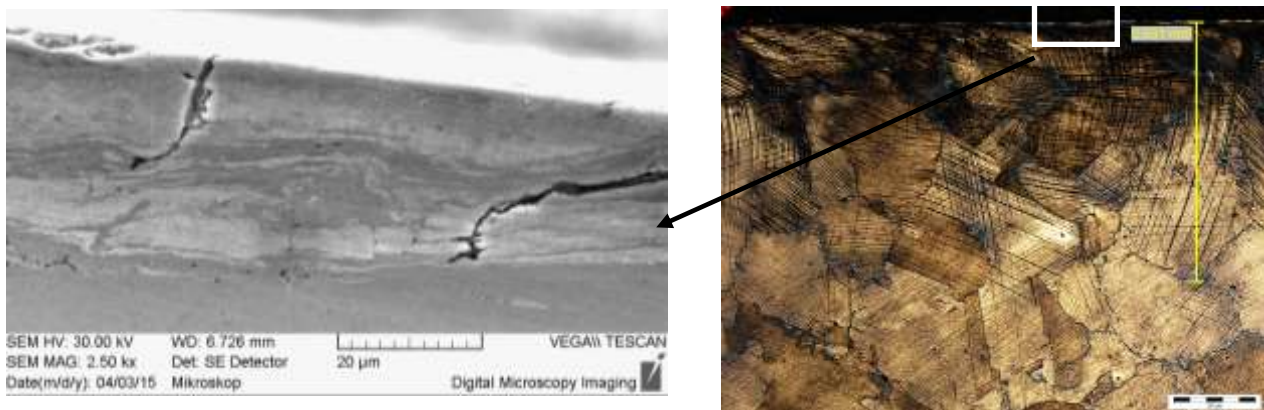
Fig. 3 Creation of “WEL” like surface layer

The structural analyses were performed in the final state of the test, i.e., after 1mil. loading cycles. Intensive dislocation hardening to a depth of 700 μm was observed by metallographic analysis in cross sections directed according to the rolling contact (Fig.3). Two different mechanisms of surface microcrack initialization were involved in the wear during the rolling contact.

The first one was the creation of a surface layer similar to "White Etching Layers" (WEL) typically formed in pearlitic railway steels. This name was derived from its white appearance, resulting from its higher corrosion resistance to metallographic etching. This contrast phase was created by simulated contact fatigue loading

to a depth of 30µm, and a different level of plastic deformation inside these layers was typical. Voids and microcracks were created directly in this layer approximately perpendicularly to the contact surface, apparently as a consequence of the fragility of these microvolumes. Surface hardness in those positions, measured to over 700 HV10, proved limited decrease in plasticity. Microcracks initiated at the interface with bulk material or in sublayers with less intensive plastic deformation typically propagated along the interface with different intensity of induced transformation. This tendency is pictured in detail in Fig. 3 for the tested material without prior explosive hardening. Initiated microcracks propagated until wear flakes were formed at the surface. Based on continuous contact surface observation, this stage of the degradation process corresponds with the onset of increased wear rate at about 300 thou. cycles of experimental loading.

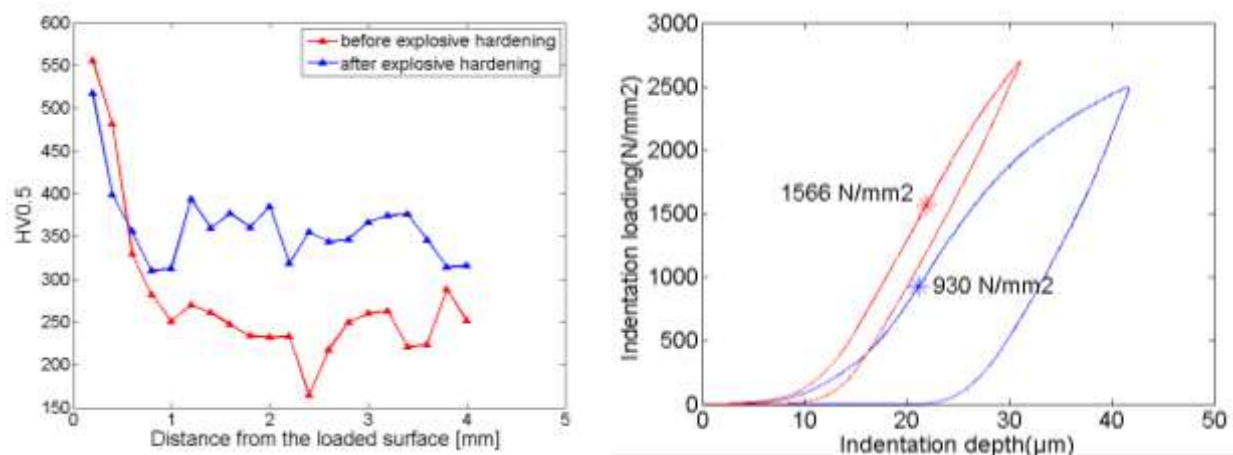
Fig.4 Hardness gradient and indentation test record for compared stages of Hadfield steel

The macro range (i.e., over 2N) of the instrumented indentation test using a Vickers indenter according to standard ISO 14577-1 was used, so the measured parameters were not significantly influenced by the contact area or the actual shape of the indenter tip. The test procedure was force controlled. A continuous recording of the force and the relevant indentation depth was the result of the test. The results presented in Tab. 1 are the mean values of 10 measurements. The higher standard deviation of the values after contact loading reflects the local differences in surface damage, i.e., the effect of repeated creation of surface hardened microvolumes up to the “WEL” state simultaneously with the uncovering of the “parent” material due to spalling of the layers. Martens hardness (HM) includes plastic and elastic deformation. The mechanical work during the indentation procedure (W_{total}) is only partly consumed as plastic deformation work. During the removal of the test force the remaining part is set free as the work of elastic reverse deformation W_{elast} . The relation $\eta_{IT} (W_{elast} / W_{total}) \cdot 100[\%]$ reflects the differing residual plastic capacity of the surface layer during rolling contact loading. The depth of the contact – fatigue strengthening needed to be determined for reliable measurements of the surface layer state. The gradient of experimentally induced surface changes was evaluated by hardness measurement directed perpendicularly to the loaded surface – Fig.4. The maximal loading force was chosen according to the depth of the intensively hardened layer at a particular measured position. Comparative yield stress $CYS [N/mm^2]$ was determined by a cylindrical indenter 1.2 mm in diameter. According to hypothesis about the behavior of the material during the extrusion

of a cylindrical indenter [3], the constant 2.57 was used as the ratio of compressive stress applied by the indenter to shear yield stress.
