ANALYSIS OF ZN-MG COATING IN DEPENDENCE ON THE EXTENT OF DEFORMATION BY DIFFERENT TEMPERATURES

ZUZÁNEK Lukáš¹, ŘIDKÝ Ondřej¹, SOLFRONK Pavel¹, KOLNEROVÁ Michaela¹, SOBOTKA Jiří¹

¹Technical University of Liberec, Studentská 2 Liberec 1, 461 17 Czech Republic, EU

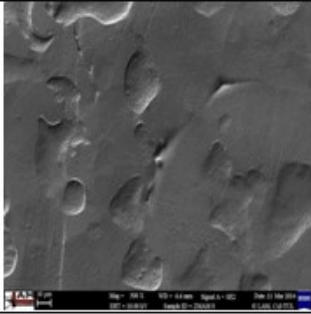
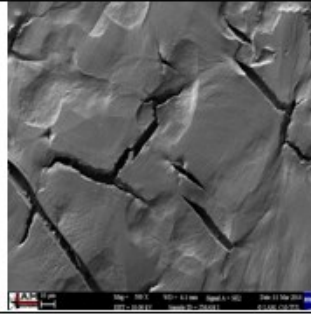
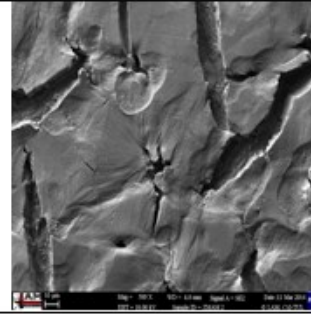
Fig. 1 The images of the surface layer in dependence on the degree of strain at the temperature of 20 °C

Electron microscope

Strain φ [%]	0%	10%	Maximum (45%)
Debye-Scherrer method

Figure 1 shows a certain level of deformation by the strain of ($\varphi=10\%$). Even by this relatively low level of strain a disruption of the surface layer is caused. Because of its fragility, the Zn-Mg coating breaks out. By a higher strain the cracks are increasing. By the strain of ($\varphi=10\%$) the width of cracks is about $5 - 6\ \mu\text{m}$ and by strain of ($\varphi=45\%$) the width of cracks exceeds $20\ \mu\text{m}$.

For the Zn-Mg coating at the temperature of 20°C is typical that it is susceptible to the creation of cranes during the forming. Figure 1 shows a certain level of deformation by the strain of ($\varphi=10\%$). Because of its fragility, the Zn-Mg coating breaks out. By a higher strain the cranes are increasing. At the temperature of 250°C by the strain of $\varphi=7$ a 15% no significant disruption of the surface layer was caused. (Fig.2). The images obtained by using the electron microscope show no significant disruption of the surface layer: The Zn-Mg coating is only deformed according to the plastic deformation of the steel sheet. By the strain of $\varphi=30\%$ cavities are probably formed at the grain boundaries. By a higher strain a surface layer can be disrupted. The experiment has proved that the creation of cranes on the Zn-Mg coating can be eliminated by forming the material at higher temperatures. For a further research, the temperatures, by which the surface layer is not disrupted yet, will have to be determined.

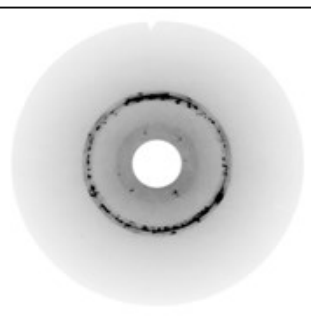
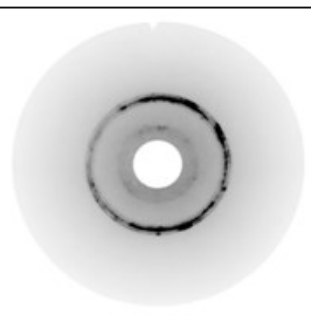
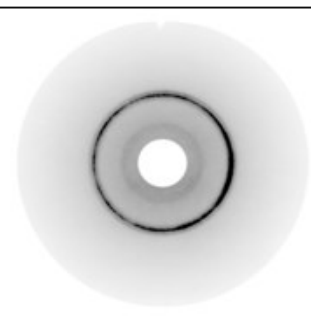
Strain φ [%]	0%	10%	Maximum (45%)

Based on the comparison of the results obtained by using the electron microscope analysis and the X-ray diffraction analysis certain correlation between the results of both techniques was found out. For the zero strain ($\varphi=0\%$) the diffraction line is discrete and characteristic for coarse-grained polycrystalline materials. In the case of the $\varphi=10\%$ strain the diffraction line becomes "smoother" that is an evidence of plastic deformation). By this strain the surface was disturbed. With a rising strain the surface disturbance is growing and the back-reflection pattern is continuous and shows the structure of a very fine-grained and plastically deformed material.

The back-reflection patterns obtained by the Debye-Scherrer method show that at the temperature of 20°C there is a change in the real structure of the Zn-Mg coating. Based on these results the Debye-Scherrer method could be applied to monitor the formation and subsequent development of the surface disturbance. The method is fast, simple, non-destructive and can be carried out on large specimens. The back-reflection patterns obtained by the Debye-Scherrer method show that at the temperature of 250°C is no significant change in the real structure of the surface layer. Therefore, it can be concluded that there is only a small disruption of the Zn-Mg coating.

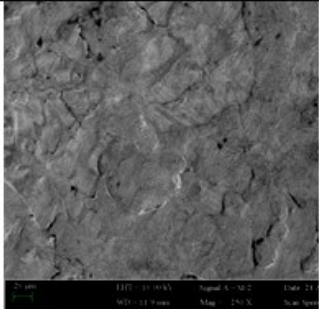
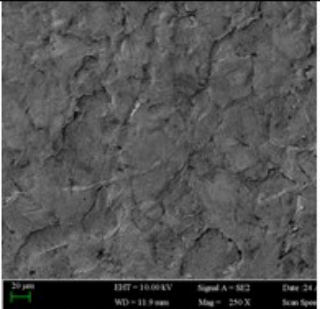
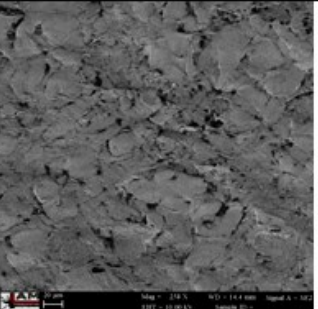
Fig. 2 The images of the surface layer in dependence on the degree of strain at the temperature of $250\ ^\circ\text{C}$

Electron microscope

Strain φ [%]	7%	15%	30%
Debye-Scherer method

The images obtained by using the electron microscope show that by the strain of $\varphi=7$ a 15% no significant disruption of the surface layer was caused. The Zn-Mg coating is only deformed according to the plastic deformation of the steel sheet. By the strain of $\varphi=30\%$ cavities are probably formed at the grain boundaries. The formation of cavities precedes the disruption of the surface layer. The higher temperature applied during the forming of steel plates covered with the Zn-Mg coating positively influence the quality of the surface layer.

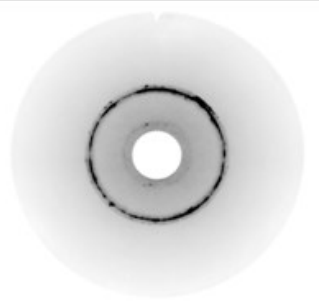
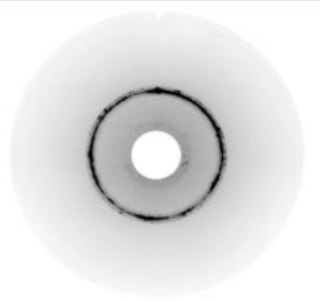
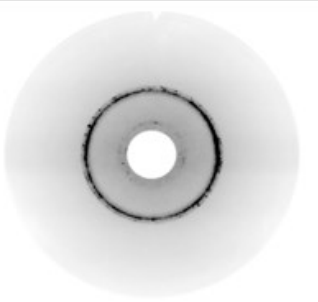
Strain φ [%]	7%	15%	30%

The back-reflection patterns obtained by using the Debye-Scherrer method show that no significant changes in diffraction lines can be proved by individual strains. Based on a small change of individual diffraction lines it can be concluded that no significant disruption of the surface layer was caused.
