IMPLEMENTATION OF COATING FOR FAILURE ELIMINATION OF DIAL GAUGES

STANCEKOVA Dana¹, SAJGALIK Michal¹, PETRU Jana², NAPRSTKOVA Natasa³, BALAZ Pavol¹

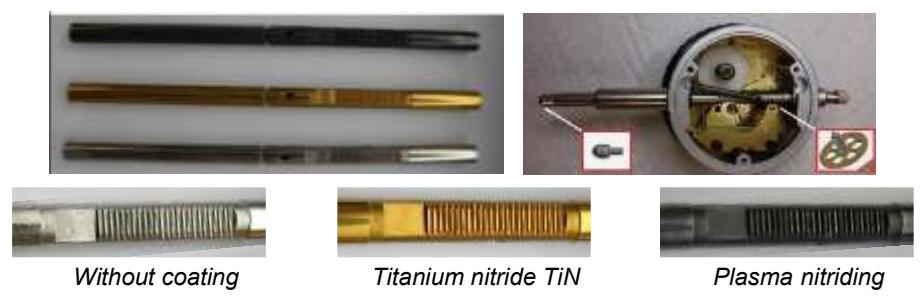
Gradually, measuring rods with different surface modifications are installed to the same dial indicator. As the measuring rod is in a direct contact with a toothed wheel and measurement is transferred through a measurement contact, even these parts are constantly changed.

Fig. 3 Surface modifications of measuring rods

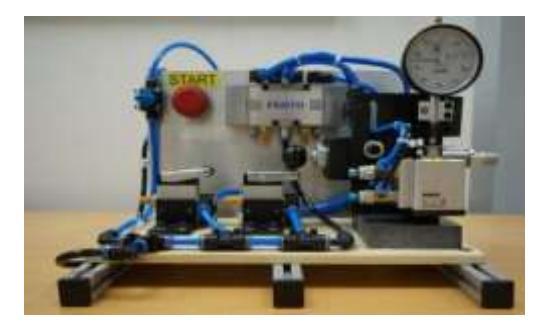
An original part is tested at first to determine the number of cycles in which there occurs a loss of metrological characteristics of the dial indicator. A pneumatic test preparation was used to test particular formats of the dial indicator., Fig. 4. A pneumatic piston in the testing preparation imitates conditions of the usage of the dial indicator in manufacturing processes.

Fig. 4 Testing preparation

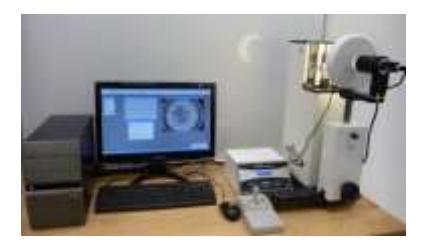
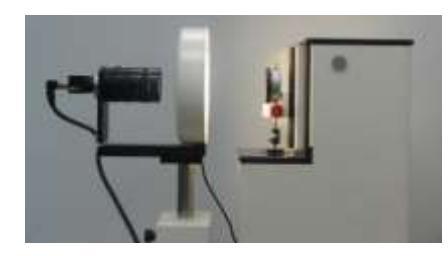
The measuring inspection system MFP100 BV was used to measure and to evaluate prescribed metrological characteristics of the dial indicator, Fig. 5. [9,10]

Fig. 5 The measuring inspection system for testing of calibration of dial indicators - MFP100 BV

Fully automatic for testing dial gages, dial comparators, lever-type test indicators and incremental and inductive probes. pointer. [9,11]

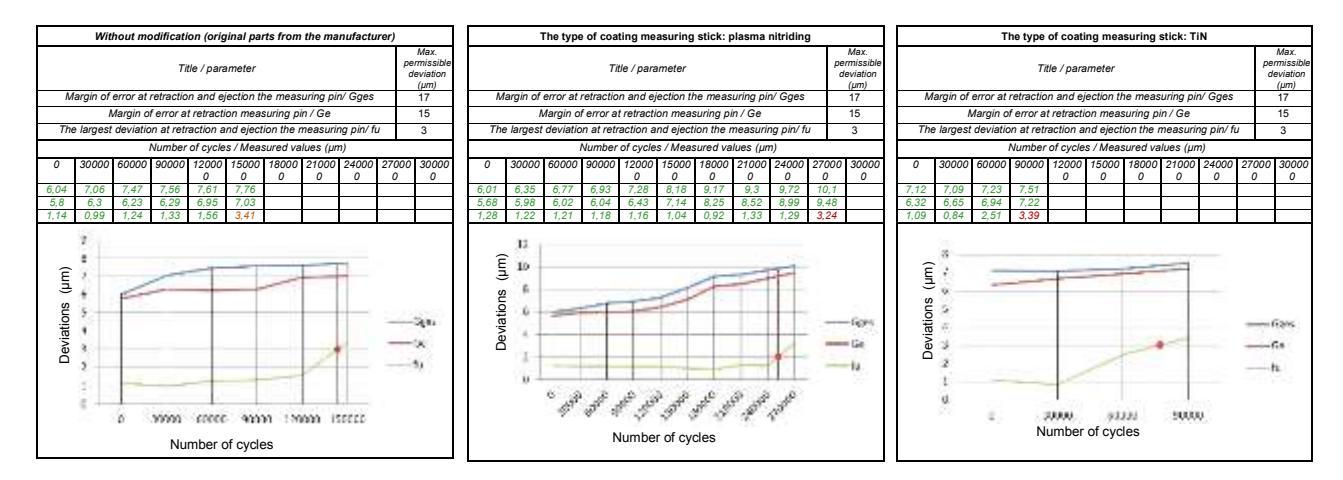
The individual testing variants of the dial indicator were tested and continuously controlled after every 30,000 cycles until specified tolerances were exceeded, Fig. 6.

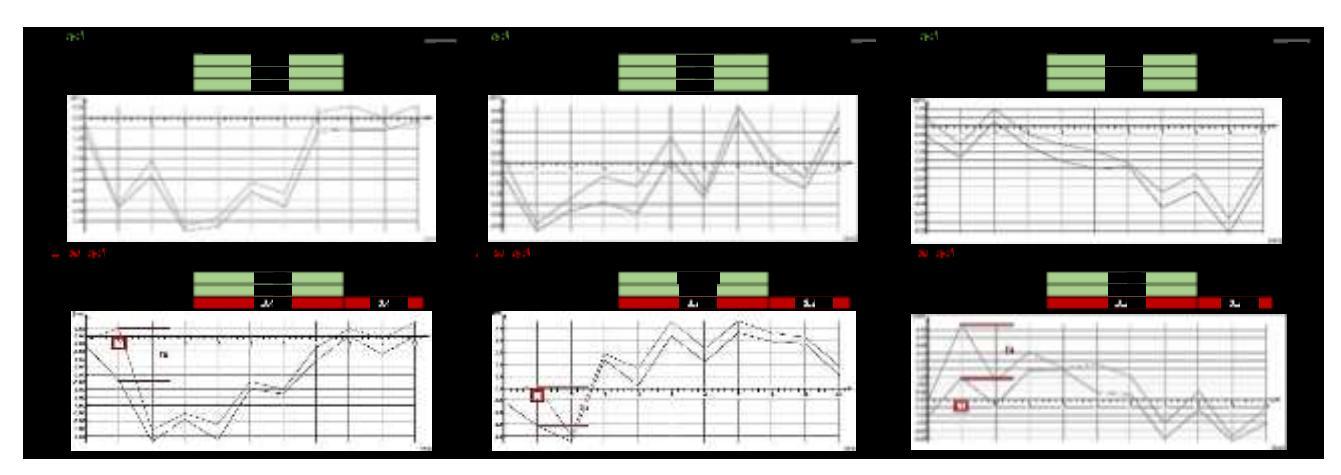
Graphs with measured values - before testing (0 cycles) and after testing, Fig. 7.

Fig. 7 A comparison of graphs of a dial indicator with a measuring rod: a – without any adjustment, b – for plasma nitriding, c – for surface modification TiN

From the stated measurements of the individual variants results the fact that the highest depreciation occured after inserting the measuring rod in the distance of 1 mm in the scale of the indicator and the main reason of a disposal of eligibility was the exceeding of the maximum deviation of a parameter f_u – reverse range – the miximum deviation in a measured period of inserting and ejecting (µm).

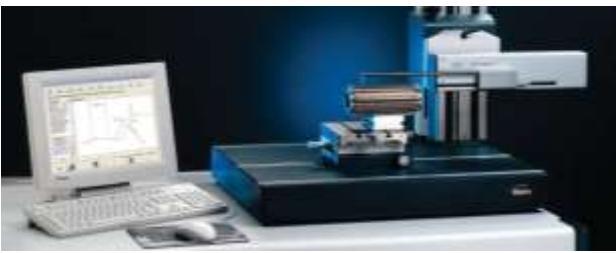
As the toothed measuring rod is in a direct contact with the toothed wheel, the both parts must be measured. The amount of loss of material caused by depreciation on the most corrupted part of the toothing is compared. The MarSurf XC 20 Contour Measuring system is used to measure and evaluate the level of depreciation of the toothing, Fig. 8.

Fig. 8 The MarSurf XC 20 Contour Measuring systém [12]
