MICROSTRUCTURE OF 08CH18N10T AUSTENITIC STEEL AFTER THERMO-MECHANICAL FATIGUE TESTS

Abstract

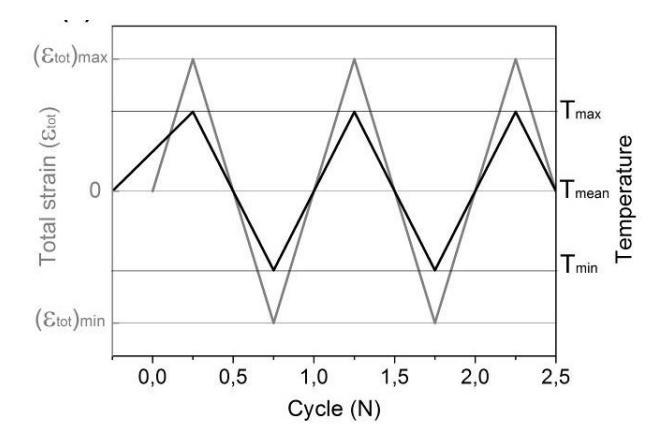
Fig. 1 Input profiles of thermo-mechanical cycles

Specimens for fatigue tests were machined out of tubes made of 08Ch18N10T steel (Table 1). Cylindrical specimens of 8 mm gauge diameter and 7 mm length were tested using a GLEEBLE thermo-mechanical simulator. The test was run under uniaxial tension – compression loading with total strain control. All fatigue tests were carried out at a frequency of 0,083 Hz and a triangular waveform. The longitudinal total strain was controlled by a HZT060 type linear displacement transducer at different levels of total strain amplitude (TSA) from 0.9 to 2.0%. A K-type thermocouple was welded in the middle of the gauge length to control and measure the temperature of the test specimen. The TMF tests in a temperature a range from 150°C to 270°C were carried out in the in-phase conditions and with a heating and a cooling rate of 20 °C/s. Temperature and stress cycling is evident in Fig. 1.

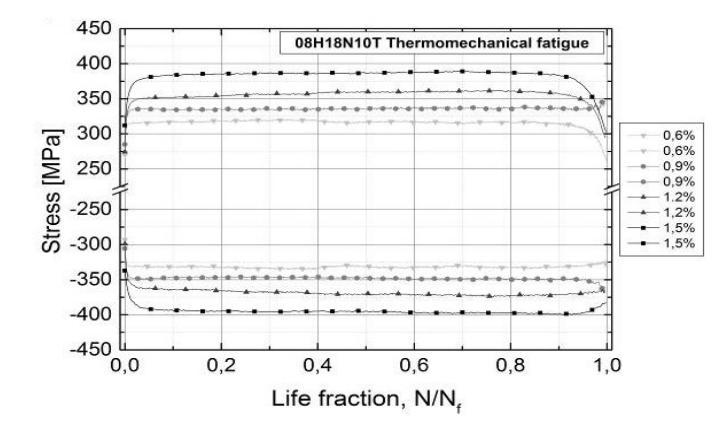
Fig. 2 Cyclic stress response of the tested material. N represents actual number of cycles and N_f number of cycles to rupture

The cyclic stress response of the tested material is shown in Fig. 2. Other results including comparison of TMF tests with isothermal fatigue tests at 260°C will be published [3]. In the strain controlled low cycle fatigue, the cyclic stress behaviour is one of the most important features of the material, as it represents the

path of the stress amplitude during the fatigue life. The cyclic stress response of the material investigated is shown in Fig. 2 for different total strain levels.

Three different stages of the cyclic stress responses at all strain ranges and temperature levels can be distinguished. Cyclic hardening occurred at the beginning of the fatigue test, which is typical for austenitic stainless steels under strain-controlled LCF conditions [1, 2]. This first stage was observed up untill about 0.05 of life fraction and stress increase was more significant at higher strain amplitude levels. The second quasi-stabilized stress stage lasts up to about 0.9 of life time fracture. The following softening is related to cracks nucleation and propagation.

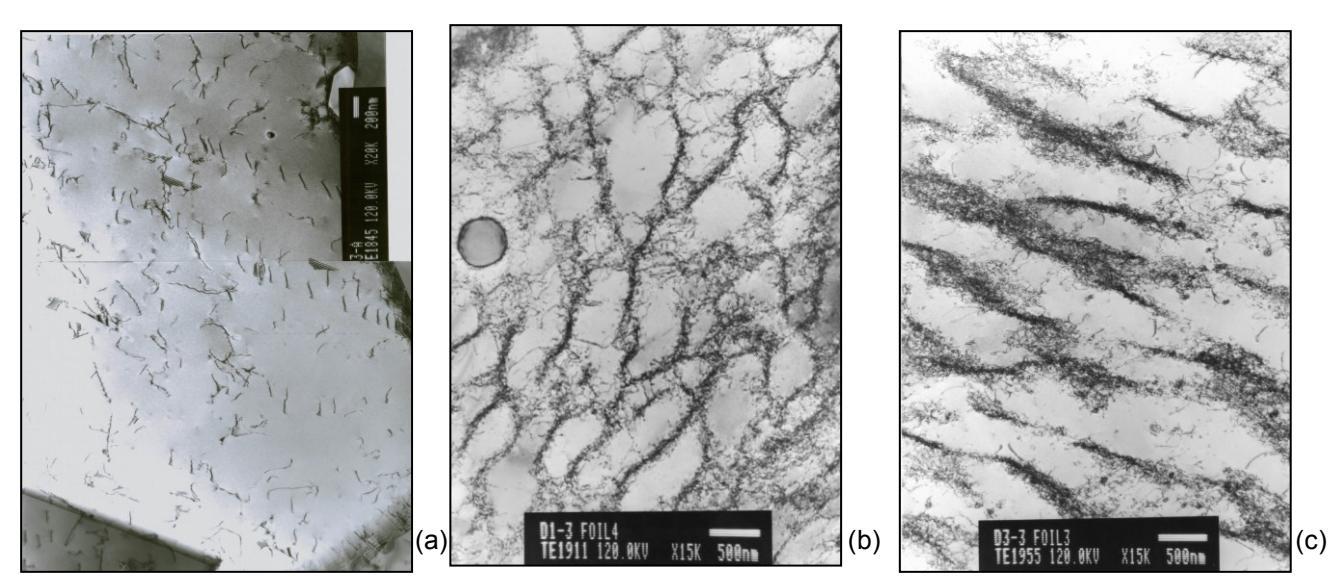
Fig. 3 Dislocation substructure of fatigued specimens: a) CUF = 0%, b) CUF = 5%, c) CUF = 25%. TEM

Dislocation substructure of the steel in as received conditions consisted of a disordered dislocation network with a low dislocation density of $0.7 \cdot 10^{14}$ m⁻² (Fig. 3a). Dislocation-poor and dislocation-rich areas were formed during the cyclic deformation similar to those, which were observed in fatigued monocrystals of FCC

metals [7]. The dislocation substructure observed in individual austenitic grains in polycrystalline steel depended on their crystallographic orientation and relation to applied stress. Dislocations concentrated in areas called veins separated by channels are shown in Fig. 3, which were taken in a grain orientated near the [110] pole. According to the model published by Mughrabi the vein substructure consists of bundles of edge dislocations and channels containing some screw dislocations [8]. Such structure precedes formation of persistent slipbands (PSB) and dislocation cells [7].

Transition from veins into persistent slip bands is shown in Fig. 3c taken in orientation near the pole [123]. The width of veins decreased the number of cycles increased and the persistent slip bands (PSB) were formed. Cell substructure was observed in grains if two slip systems were activated as shown in Fig. 4a of the grain orientated near [012] pole. Wavy persistent slip bands separated by dislocation-poor channels occurred in grains, where only one slip system was active (Fig. 4b). Therefore well-developed cell substructure as well as structure with persistent slip bands was observed in one specimen. Wavy persistent slip bands seemed to pass into a labyrinth-type substructure [7] in advanced stages of fatigue life (Fig. 4c).

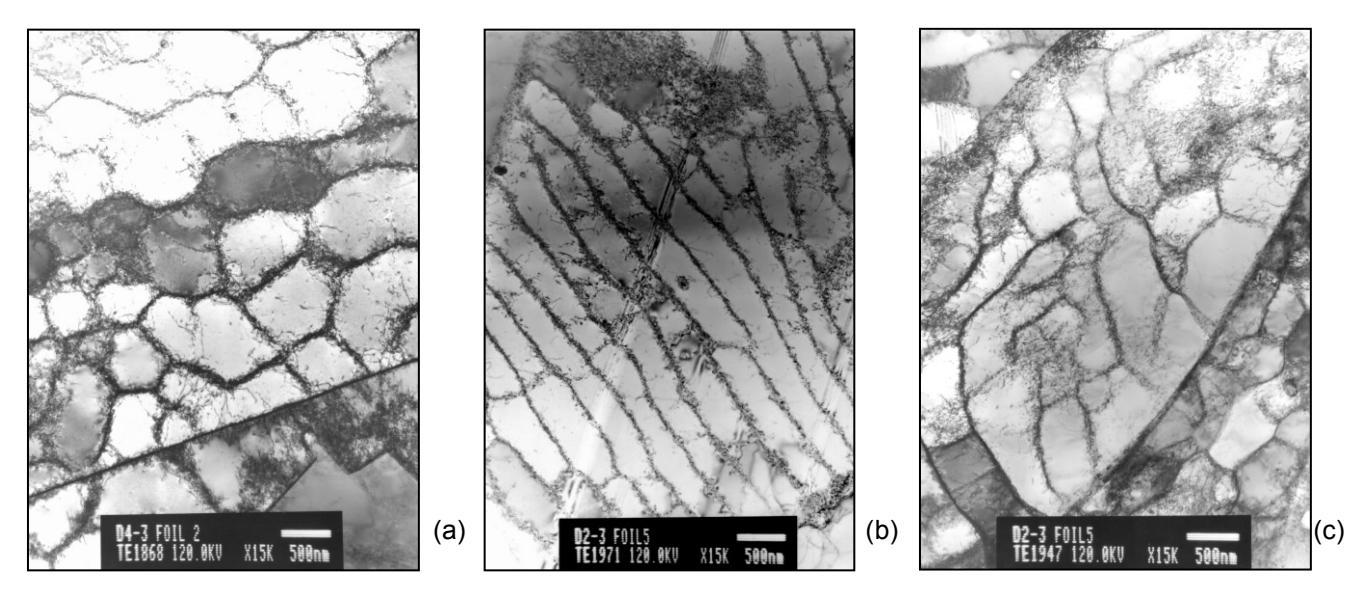
Fig. 4 Dislocation substructure of fatigued specimens: a) CUF = 50%, b) and c) CUF = 70%. TEM

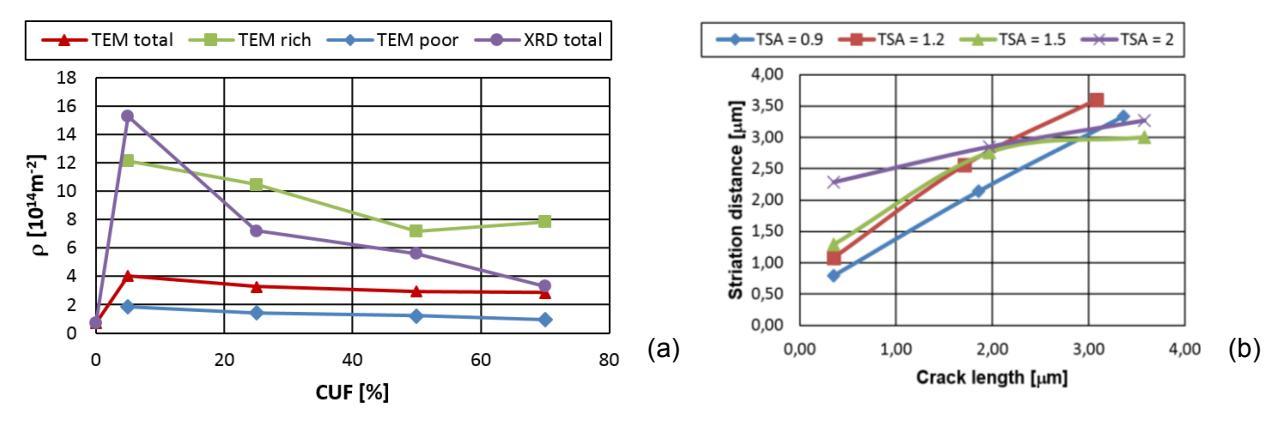
Fig. 5 Quantitative evaluation: a) dislocation density and b) striation distance

Dislocation densities in fatigued samples were measured separately for dislocation-rich and dislocation-poor areas. The nature of dislocations was taken into account. It was assumed according to the literature [9] that edge dislocations occurred in dislocation-rich areas (veins, persistent slip bands or walls), while screw dislocations were present in dislocation-poor areas (channels or interior of cells). Total dislocation density was also determined using X-ray diffraction. Results are plotted against CUF in Fig. 5a. Conditions of X-ray diffraction measurement are described in another paper submitted for publication [3]. After an initial increase in dislocation density, a gradual decrease was seen; the course is similar for both measurement methods nevertheless dislocation density determined from TEM micrographs was relatively low. The reason may be firstly the difficulty of resolving individual dislocations in dislocation rich slip bands, secondly the dependence of dislocation visibility on its nature and thirdly too relatively small volume of material evaluated by TEM as TEM microscopy is a highly localized method. The nature of the dislocations was determined using analysis of the broadening of the X-ray diffraction lines. It was found that screw dislocations prevailed in as received conditions and in the specimen of 0.05 CUF, while edge dislocations prevailed in other fatigued specimens with CUF from 0.25 to 0.70 [3]. During fatigue life from CUF of 0.05 to 0.70 the size of dislocation cells decreased from 825 to 645 nm, while the distance of persistent slip bands did not seem to change; the value of 580 nm was determined for CUF of 0.70.

fracture surfaces (Fig. 6b). The distance between them increased in the direction from the initiation center to the end of the crack (Fig.5b).

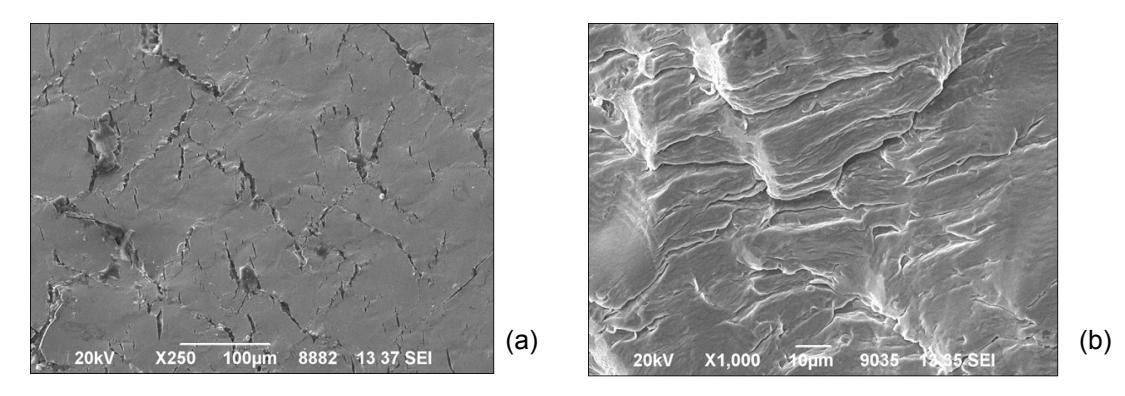
Fig. 6 Fatigued specimen with TSA = 2.0%: a) surface of the bar, b) fracture surface near the crack origin. SEM-micrographs.

Fatigued specimens showed several major cracks (for the low total strain amplitude) and a lot of cracks (for the higher total strain amplitude) originating on the surface of the test bars. These small cracks were often connected to each other and formed a regular network. Bands with apparent plastic deformation were observed between individual cracks at high total strain amplitude (Fig. 6a). The striations were observed at
